All Pro Home Inspections

TOWNHOUSE INSPECTION REPORT

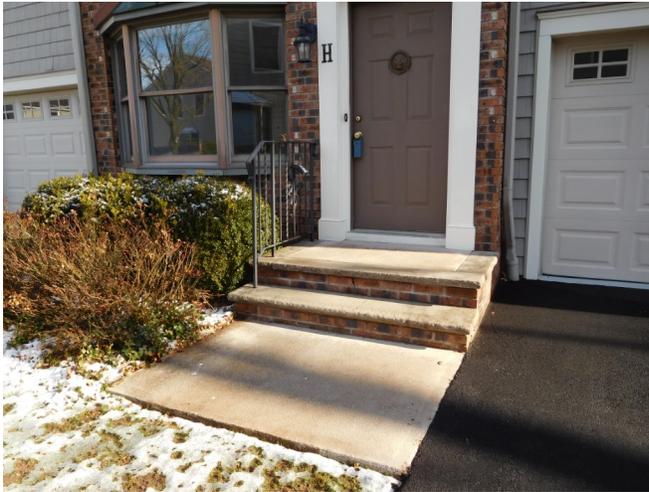
The front entrance steps are of masonry construction and appears to be structurally sound and in serviceable condition. All open areas where water can seep below the surface should be sealed. Water below the surface can freeze in the winter causing cracks to develop.

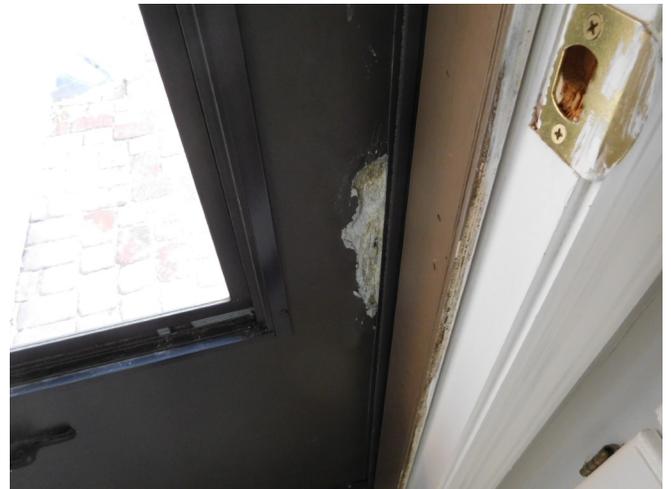
The rear storm door has some damage but is still useable.

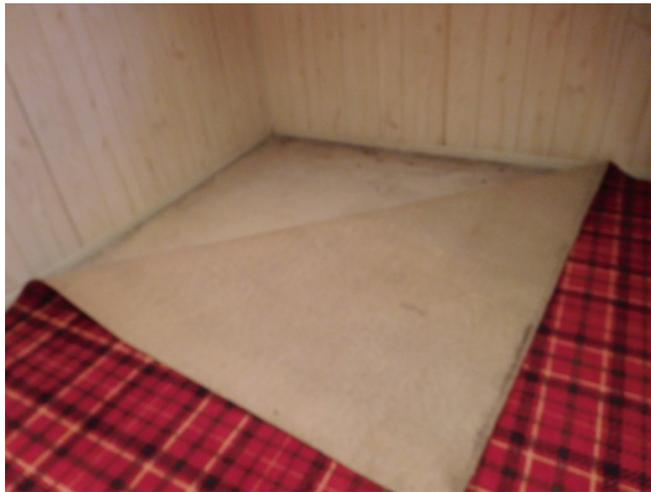
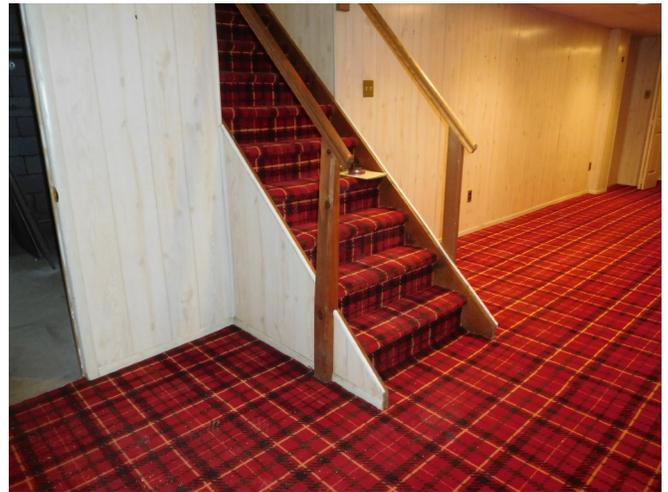
Some efflorescence is noted; however, this does not necessarily indicate significant water penetration or accumulation. At the time of inspection, no water penetration was observed. Predictions in regard to water penetration are based on indications and conditions at the time of inspection. Seasonal conditions often cannot be accurately forecast based on a single inspection. It is highly recommended that you contact the present occupants who can provide further information concerning any previous incidents of water penetration. It is necessary to occupy a building through the wet seasons prior to assuming the basement or crawlspace is completely dry.

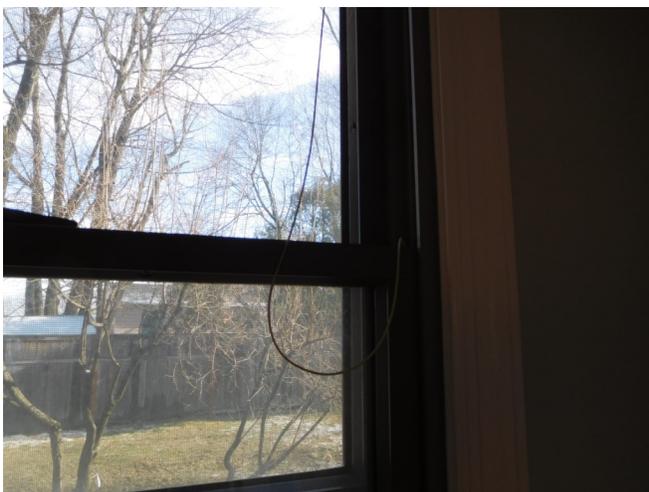
The right side dining room window has a loose spring cord on the right side, but the window still opens and closed properly.

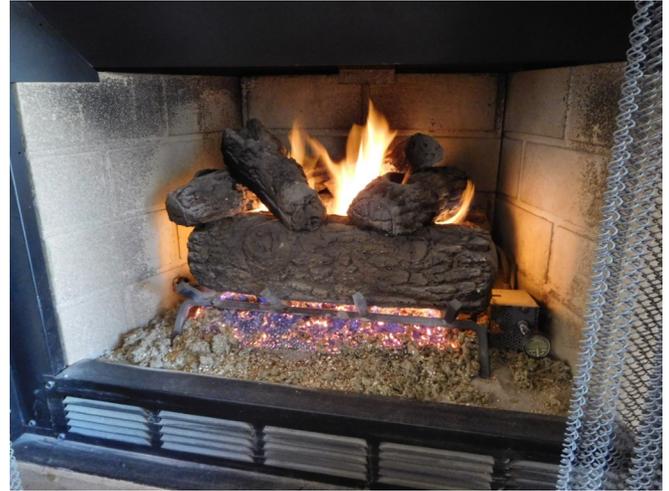
The damper for the fireplace is operable but needs to have a clamp installed on the damper to prevent the damper from staying closed when the fireplace is turned on which will cause dangerous carbon monoxide gases to enter the home.

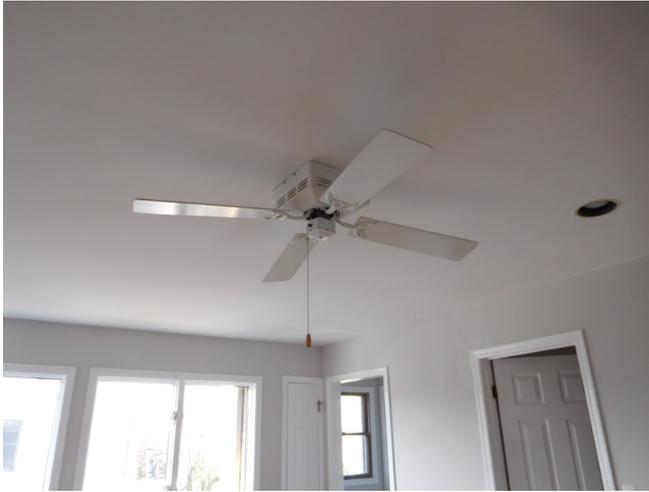
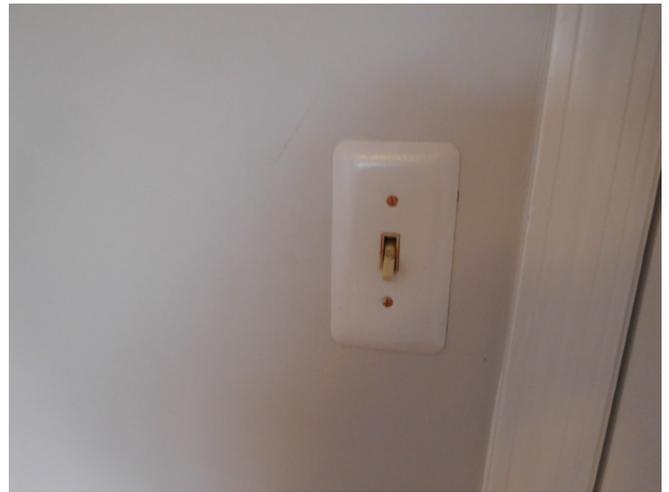
There is a loose electrical receptacle in the bedroom that needs to be secured in place.

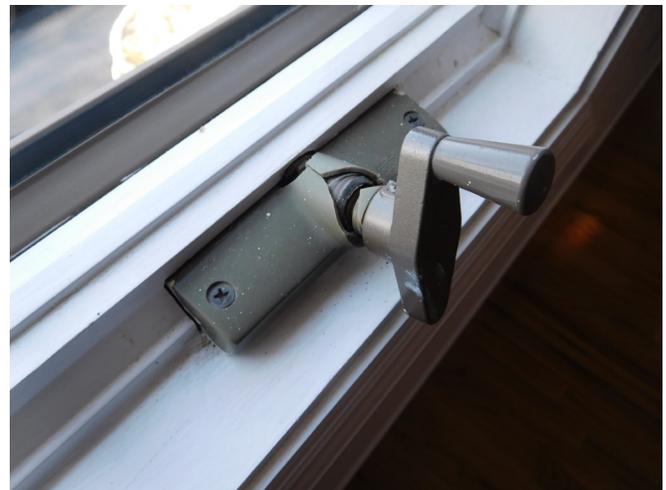
Several of the windows are missing screens. An inventory of the screens that are not installed was not conducted.

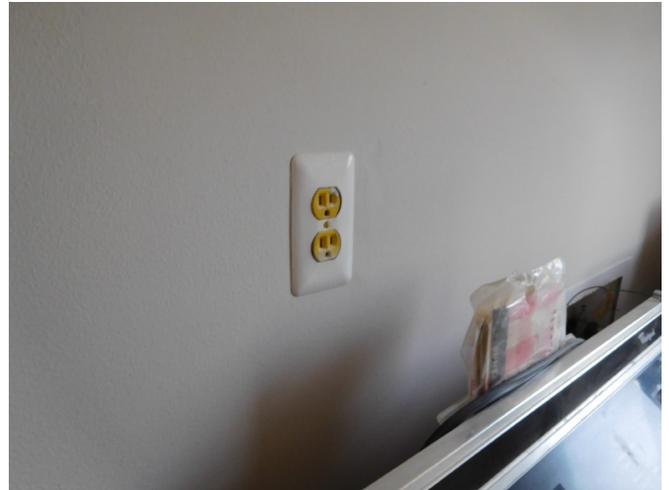
The kitchen outlets need to be GFCI protected and some other receptacles. Ground Fault Circuit Interrupter (GFCI) electrical outlets and breakers are a significant safety improvement and are required for bathrooms, kitchen countertop outlets, garages, unfinished basements, outside outlets, etc. to reduce potential electrical hazards in wet areas.

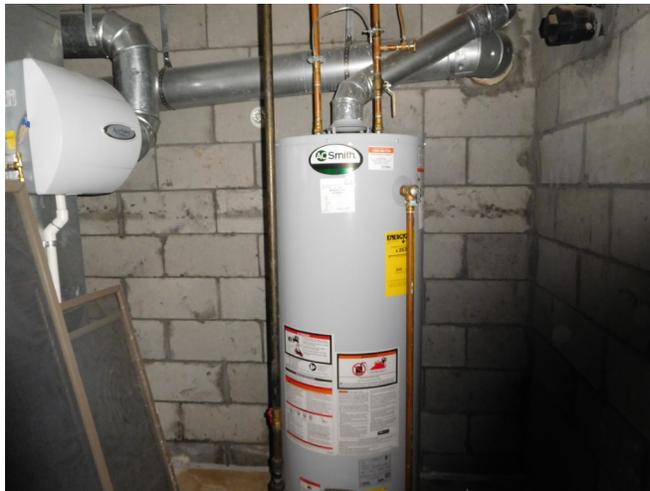
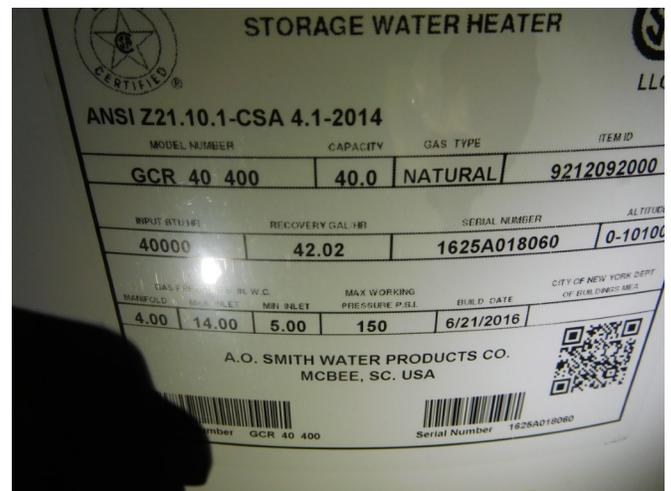
The relief valve on the water heater that is leaking needs replacement and an expansion tank needs to be installed to prevent the relief valve from leaking again.

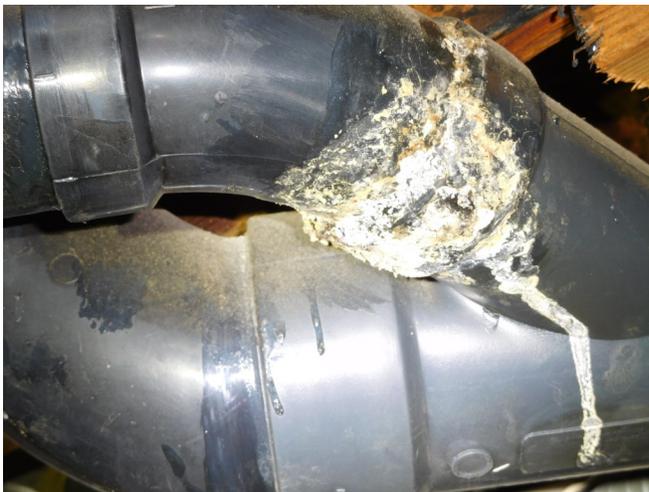
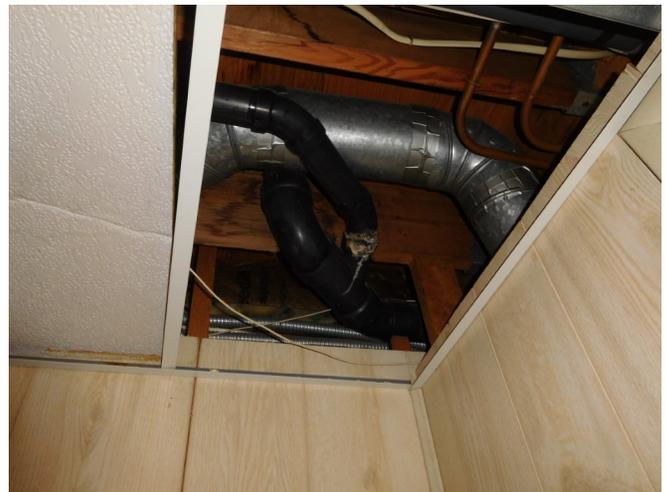
There is an active leak in the half bathroom drain line in the basement ceiling that needs repair. To properly repair this leak all the drain fitting will need to be removed that is not a simple job. It likes like someone tried to repair this leak with cement that did not stop the leak. It was stated that a leak from the 1st floor bathroom was repaired which may have been another leak not seen at the home inspection.

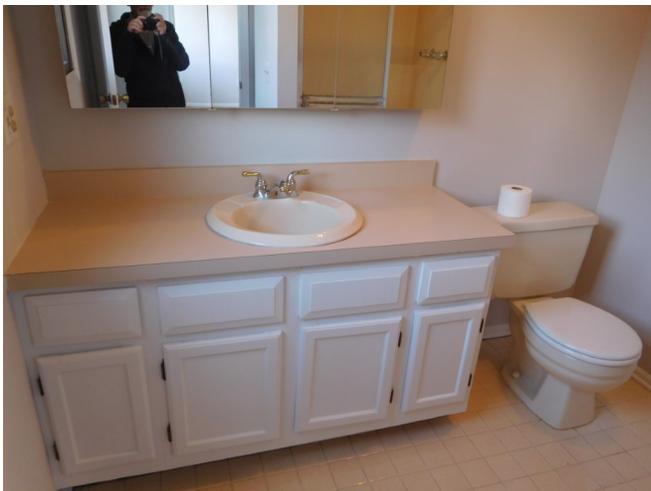
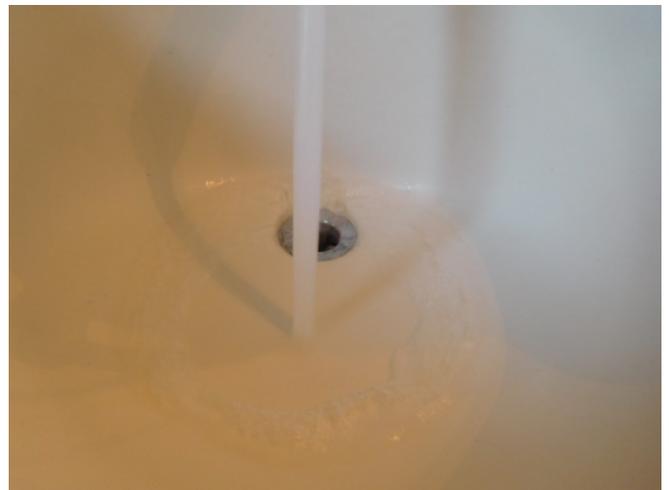
The bedroom bathroom sink drain is missing a stopper to fill the sink with water/

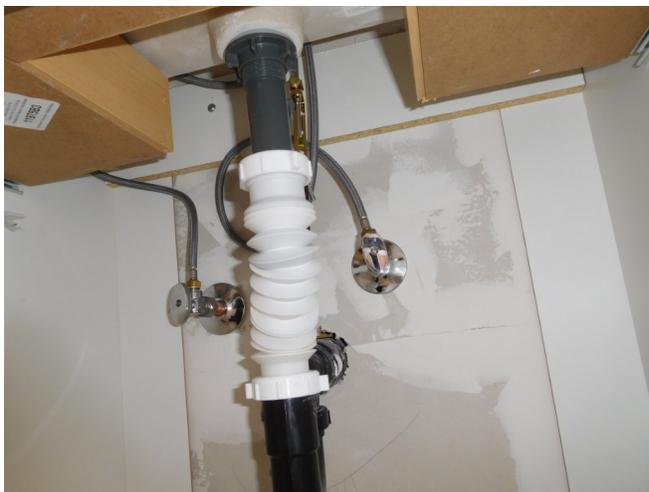
The flex drain for the bathroom sink is not recommended because over time it will start to smell from soap scum collecting in the grooves of the drain.
