All Pro Condo Inspections

Inspector: Ernest Borsellino
ASHI Certified Member # 094167
NJ Licensed Home Inspector Lic # 24GI00015700

CONDO INSPECTION REPORT

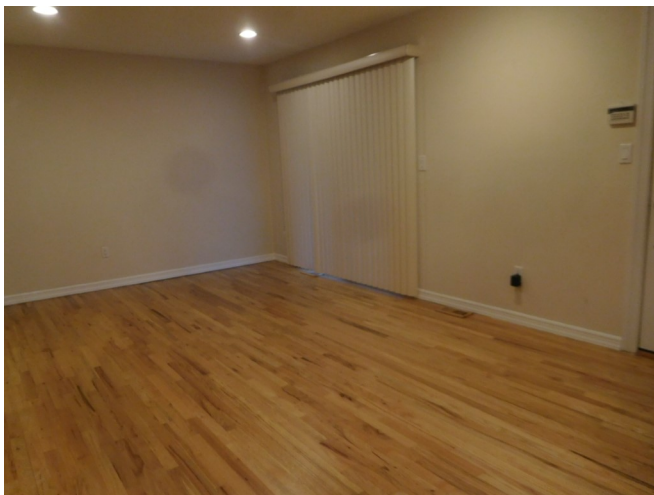
LIVING ROOM

The living room is in adequate condition. The walls and ceiling appear to be structurally sound. The floor appears to be serviceable.

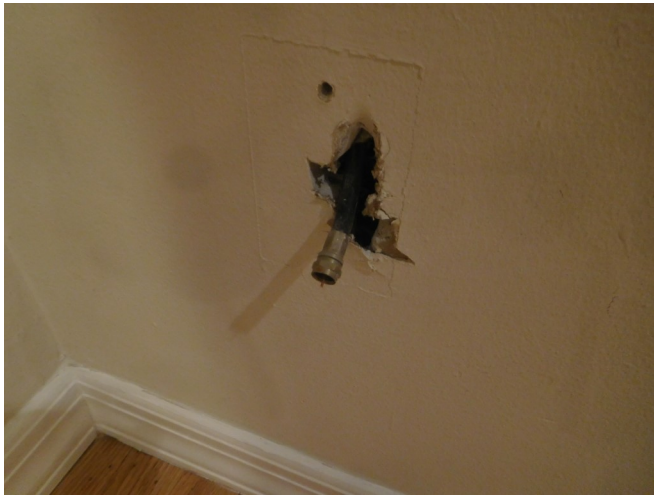
The missing cable cover in the living room for the cable that is stuck in the wall needs to have a new cover installed.

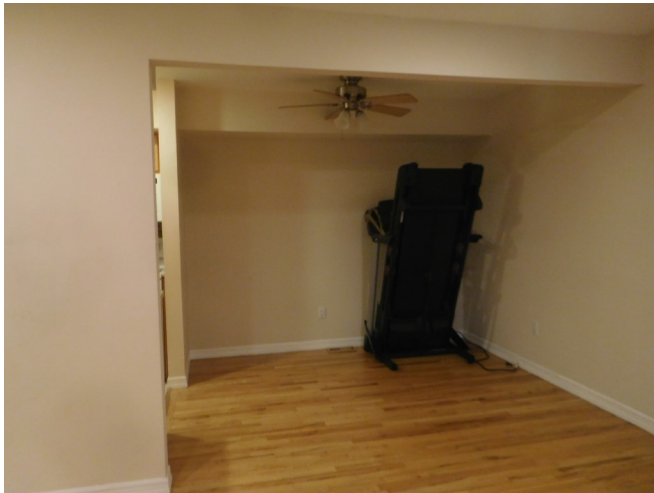
DINING ROOM

The dining room is in adequate condition. The walls and ceiling appear to be structurally sound. The floor appears to be serviceable.

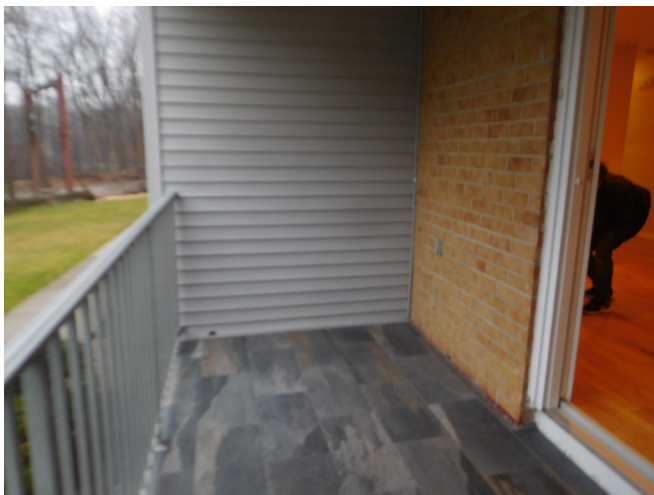
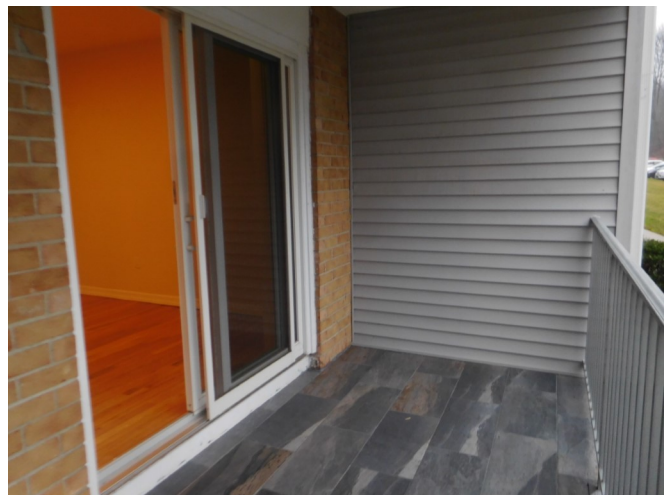
The sliding door entrance is also in adequate condition. The exterior outside receptacle is operable.

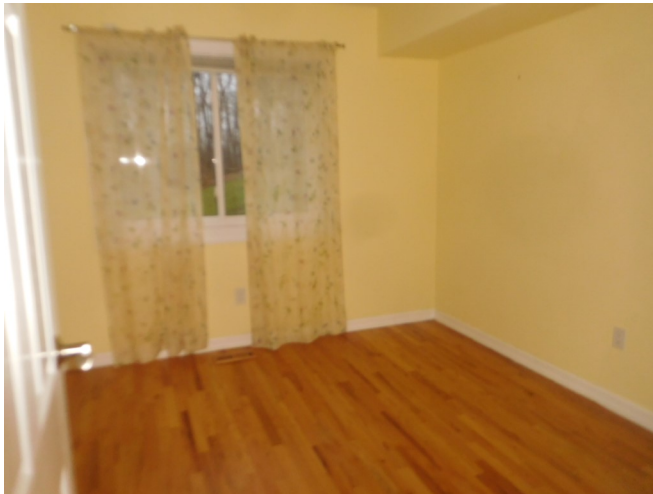
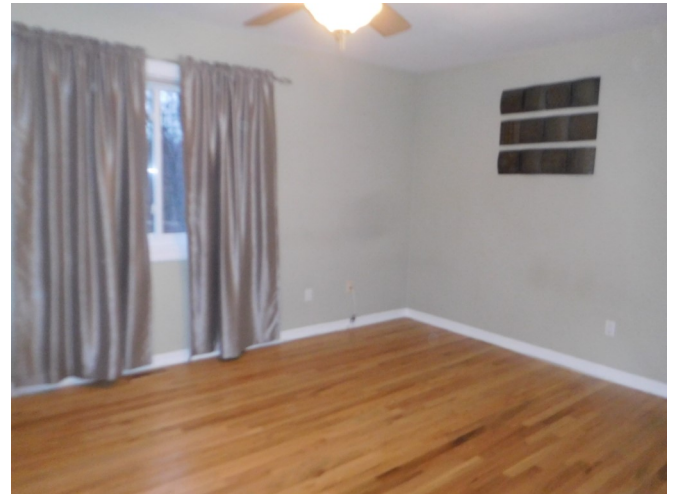
BEDROOMS

The bedrooms are in useable condition. The walls and ceilings look to be in adequate condition. Entrance and closet doors are functional. The floors are in adequate condition.

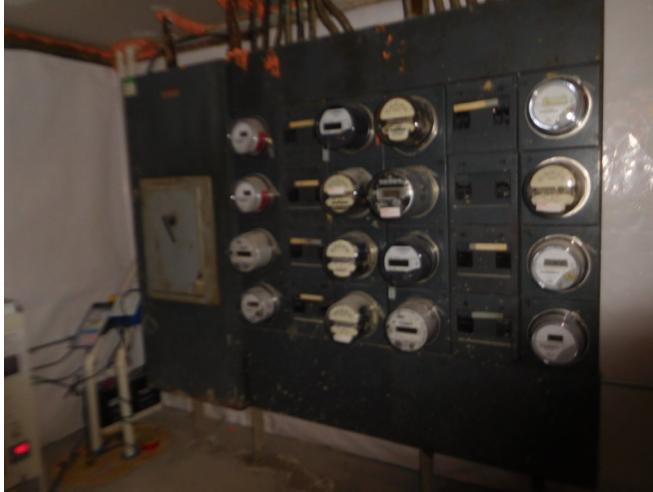
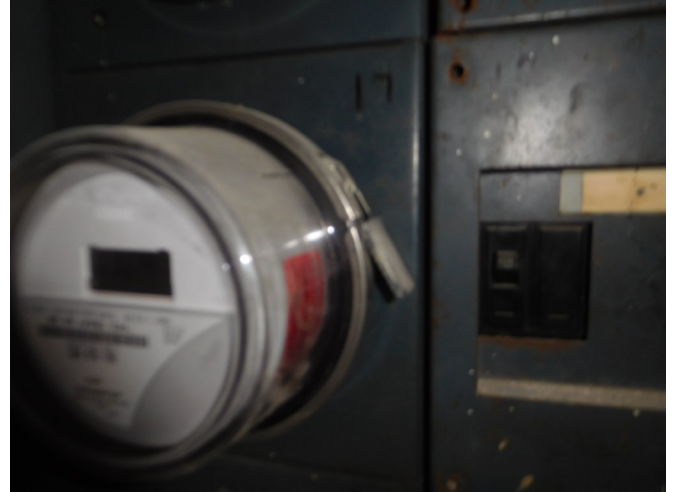
The main service disconnect has a capacity of 100 amperes, 240/120 volt electric service. Overcurrent protection is provided by circuit breakers.

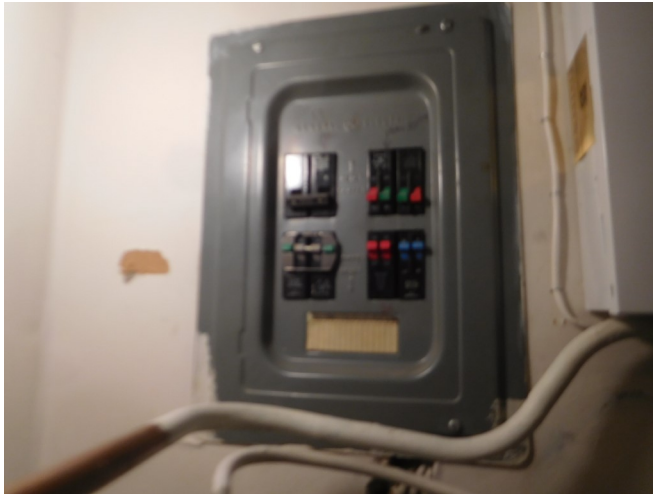
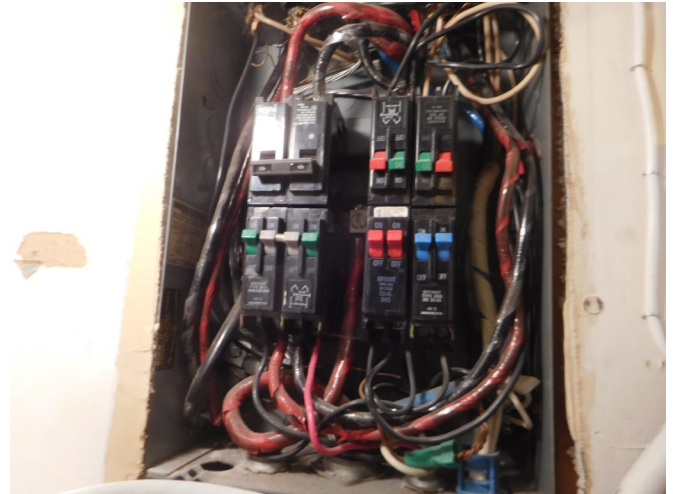
The panel was opened, and branch circuit wiring was found to be copper cable and appears to be in adequate condition.

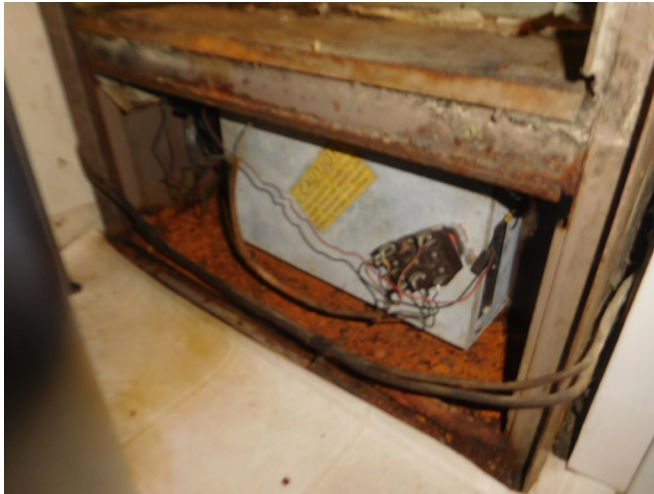
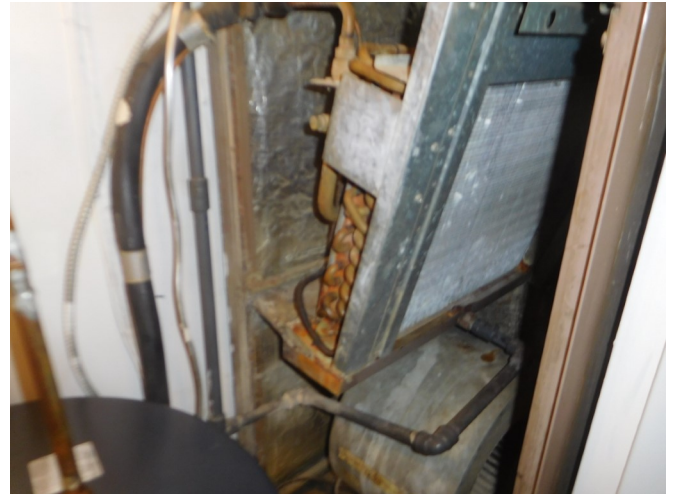
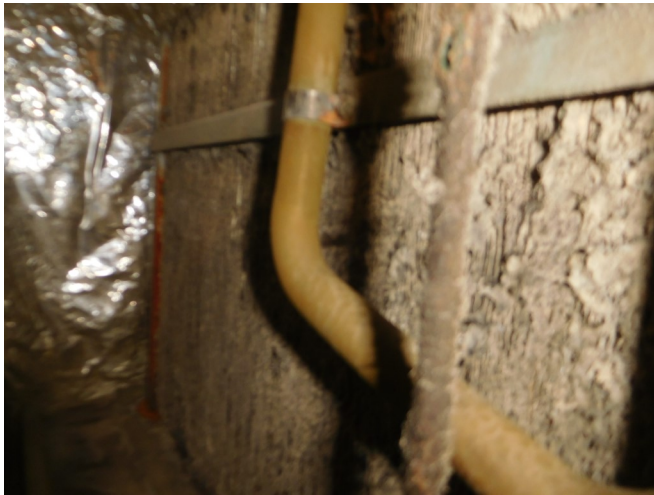
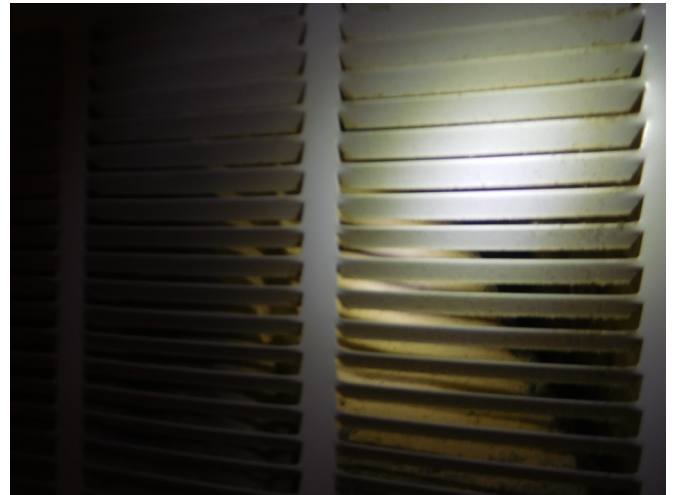
HEATING

- The furnace is 48-year-old with an overall life expectancy of 25-35 years.
- The Filter for the furnace that should be replaced every 3 months looks like it has not been replaced for many years.
- The location of the filter behind a vent cover that needs to be removed by using a drill to remove 6 screws makes it very inconvenient to change the filter which may be why the filter has not been changed. An easily removable filter vent cover needs to be installed or a cut out can be made in the return duct work to accommodate a filter.
- The interior AC coil that is completely clogged with dust because the filter hasn't been replaced regularly will need to be vacuumed off.
- Replacement of this furnace may be required if not now, in the very near future.
- The utility company should be contacted to determine how much this old unit will cost each month to heat this unit

Internal access to the heat exchanger, which is the most critical component of the furnace, is very limited and this evaluation is based on external visual inspection only.

A heating contractor needs to further evaluate the hot air heating system that is not producing adequate hot air to efficiency heat this unit because of several issues.

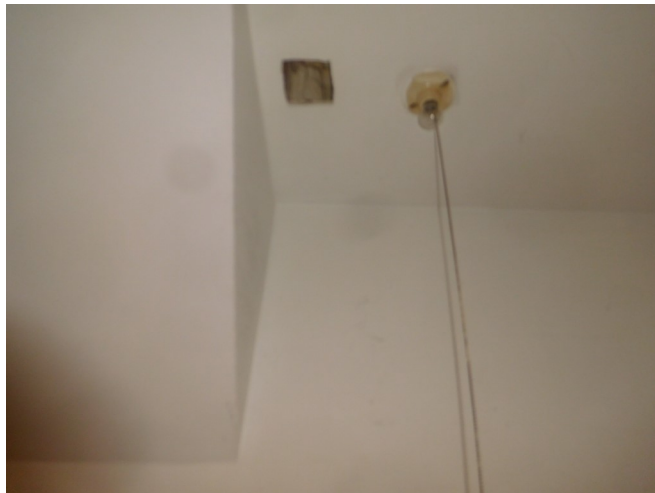
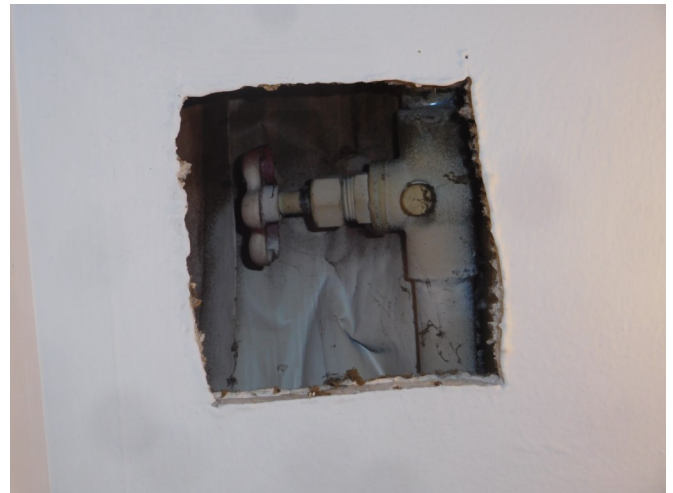
The home owner needs to be asked what the valve in the hallway closet ceiling is used for. This may be the main water shut off valve.

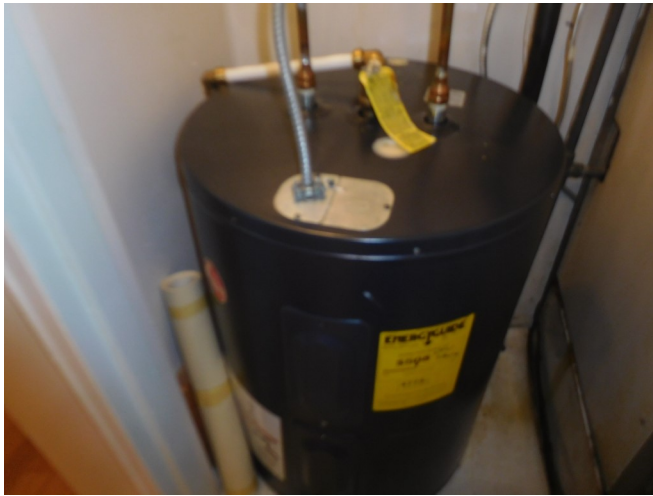
WATER HEATER

Hot water is provided by a 2012 electric unit. Units of this type have a normal life expectancy of 5-10 years. The exhaust system appears to be a proper installation. A relief valve is installed on this unit to protect against high temperature and pressure. The discharge pipe on the relief valve should always be diverted just above the floor for safety. The piping installation appears to be in adequate condition. No indication of leakage was observed.

Rheem Fury 6YR		
Serial No.	RH 0312D03741	
Model No.	82SV40-2	
Manufacture Date.	14MAR2012	
Cap. U.S. Gals.	38	
Phase	1	
Volts AC	1	1
Upper Element Watts	240	208
Lower Element Watts	4500	
Total Watts

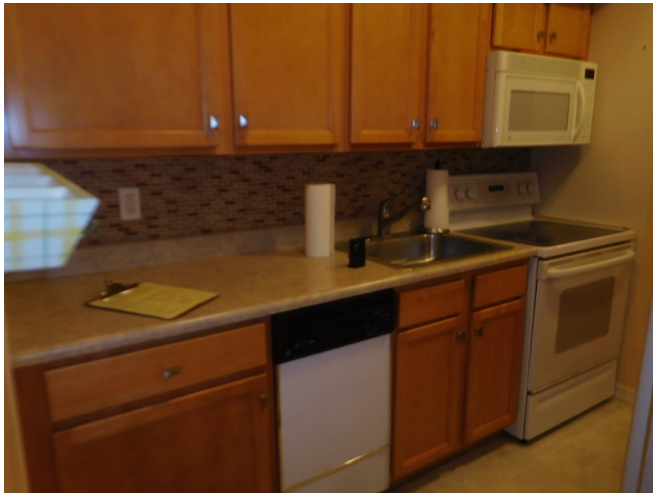
KITCHEN

The walls and ceiling are in adequate condition. The floor surface has an overall serviceable appearance. The cabinets and counter tops look basically functional. The faucet, sink and drain line appear to be in generally leak free condition.

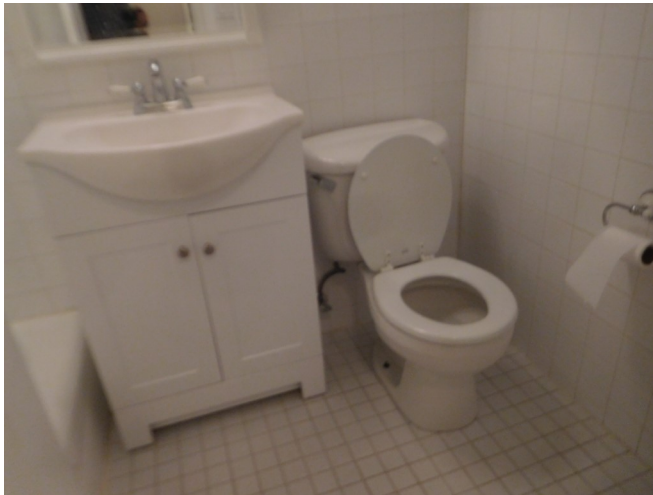
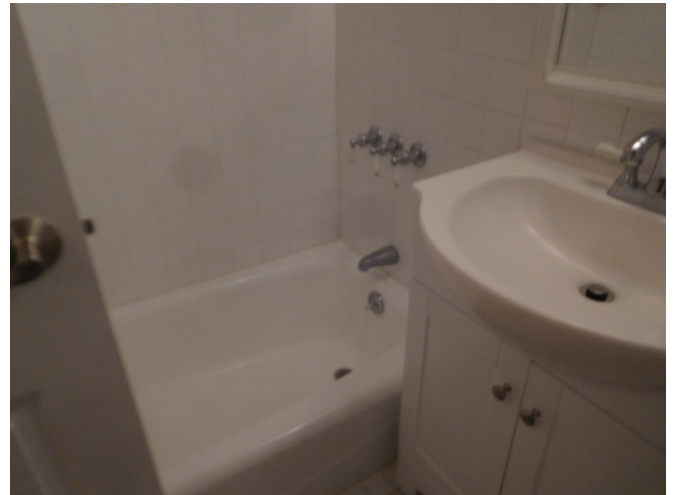
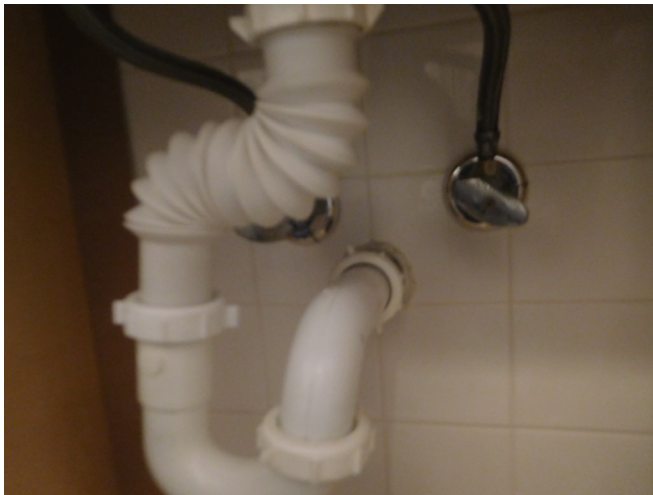
BATHROOM

The bathroom is in overall adequate condition. The floor and walls outside the bathtub enclosure appear to be sound. The tub and enclosure surfaces appear to be in generally adequate condition. The fixtures are operable and appear to be in leak free condition. The toilet is adequately secured and functions satisfactorily.

The flex drain under the bathroom sink is not a recommended drain connection because it can accumulate soap scum in the grooves and start to smell over time

All surfaces subjected to wet conditions should be well caulked, grouted and sealed as necessary to maintain them in a waterproof condition. This is important maintenance and will help to prevent leaks and deterioration of the materials behind these surfaces. Severe damage to the underlying surfaces may occur in a relatively short period of time.
