All Pro Home Inspections

TOWNHOUSE INSPECTION REPORT

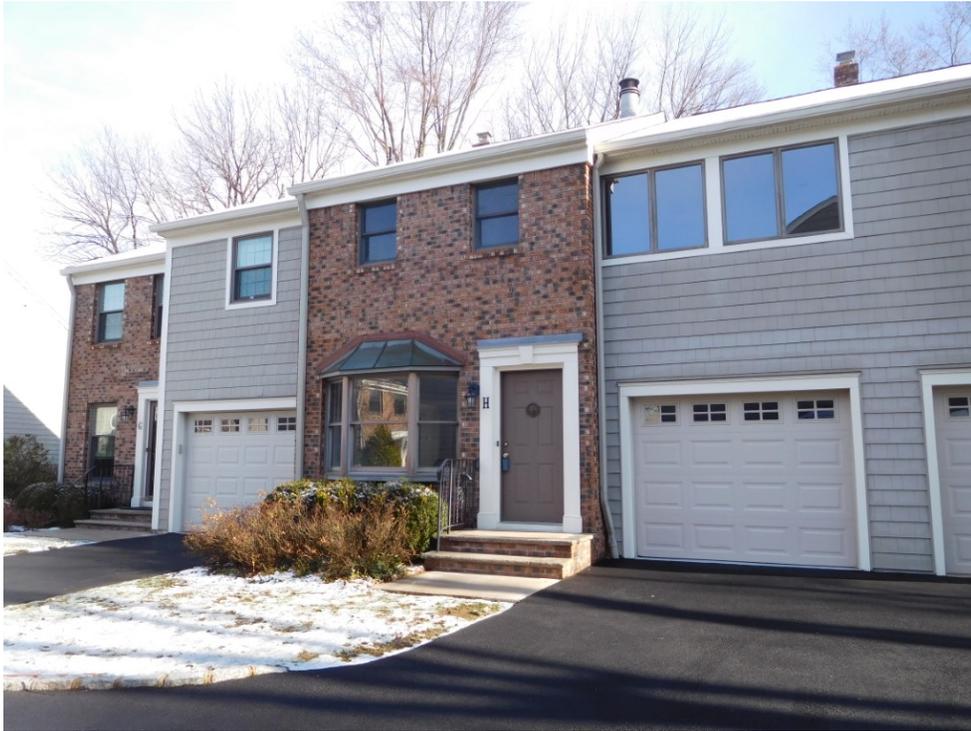
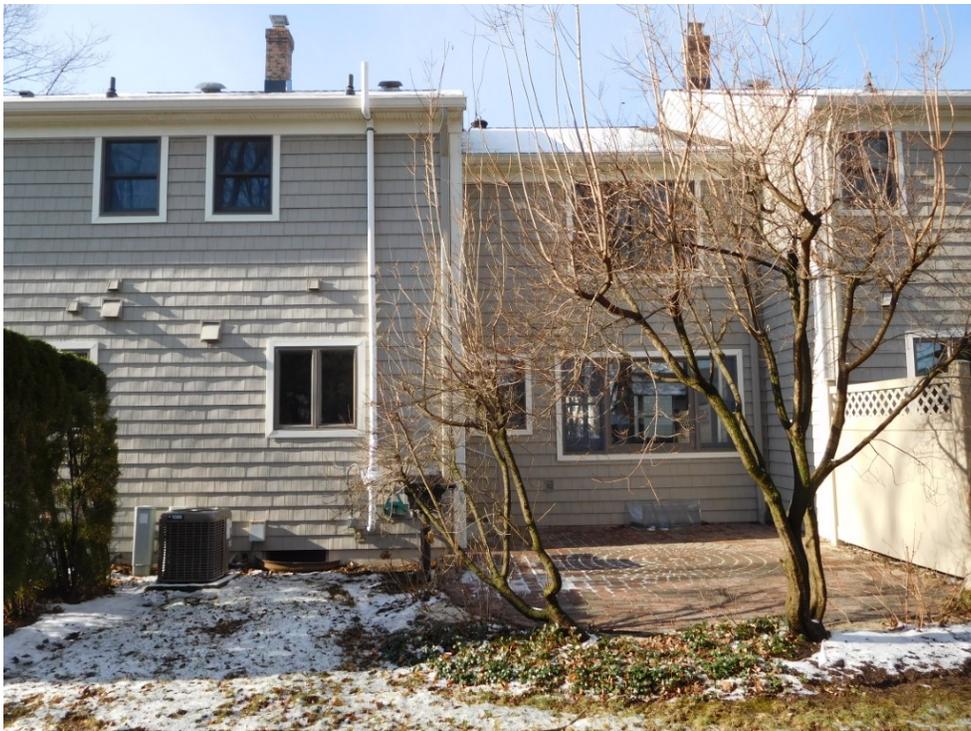
The front entrance steps are of masonry construction and appears to be structurally sound and in serviceable condition. All open areas where water can seep below the surface should be sealed. Water below the surface can freeze in the winter causing cracks to develop.

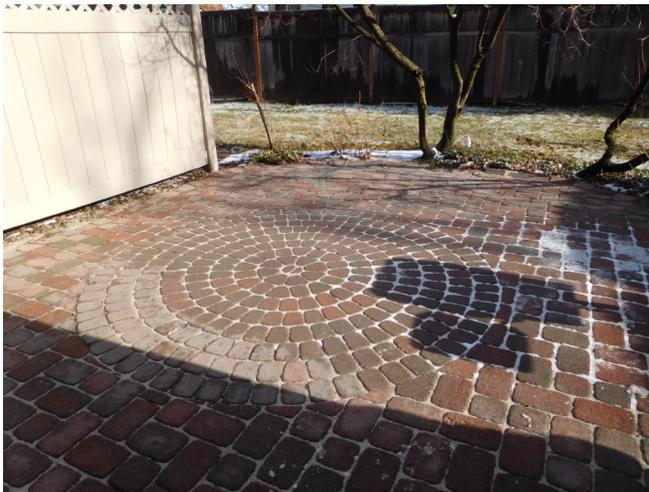
PATIO

The rear patio is in acceptable condition.

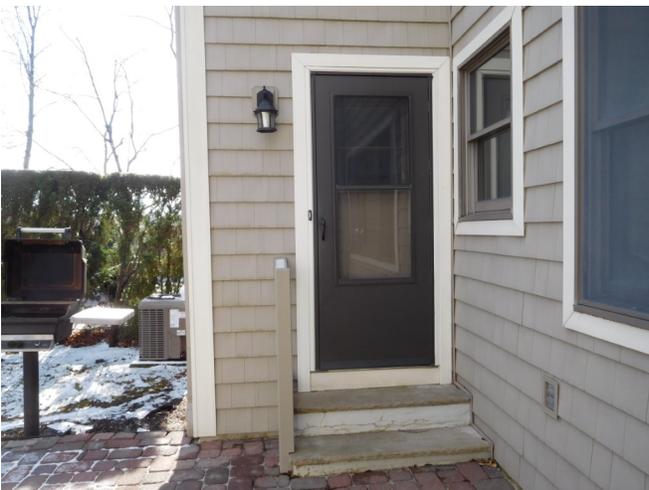
The rear storm door has some damage but is still useable.

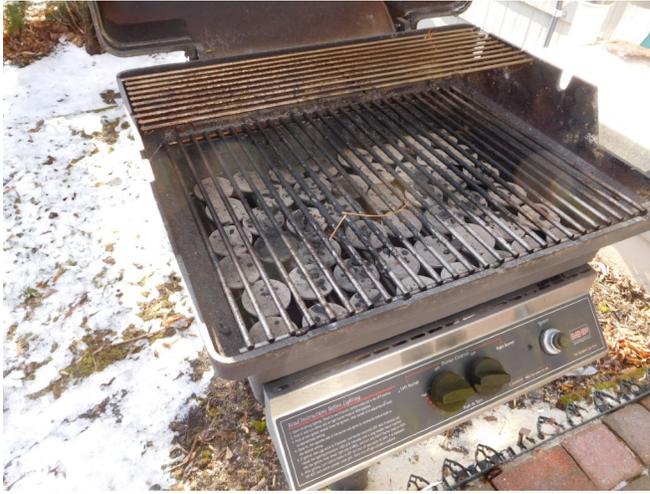
The exterior natural gas barbeque was turned on and operated.

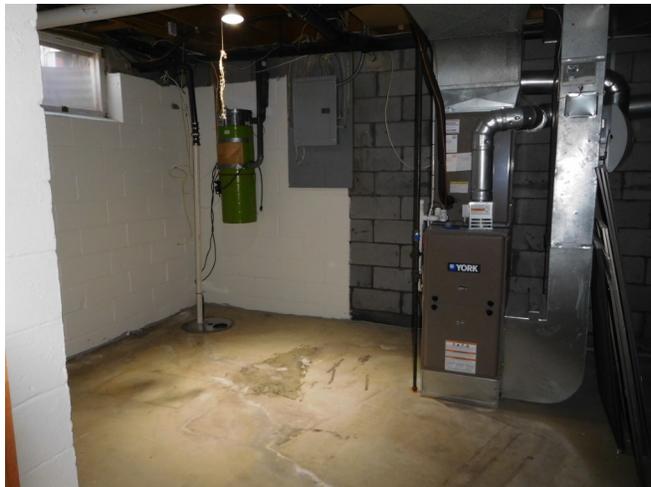
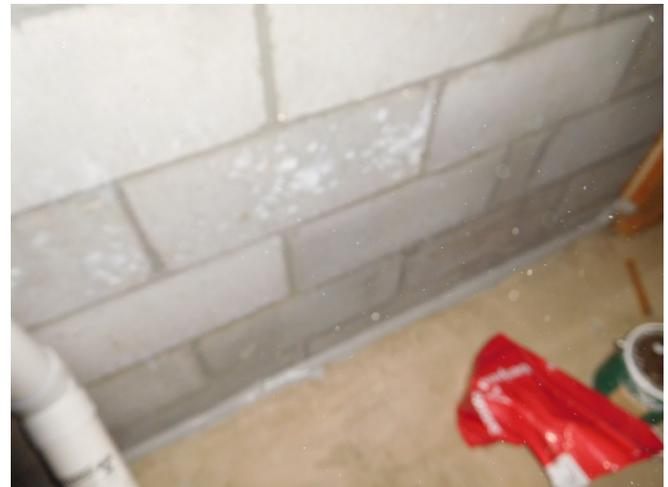
Some efflorescence is noted; however, this does not necessarily indicate significant water penetration or accumulation. At the time of inspection, no water penetration was observed. Predictions in regard to water penetration are based on indications and conditions at the time of inspection. Seasonal conditions often cannot be accurately forecast based on a single inspection. It is highly recommended that you contact the present occupants who can provide further information concerning any previous incidents of water penetration. It is necessary to occupy a building through the wet seasons prior to assuming the basement or crawlspace is completely dry.

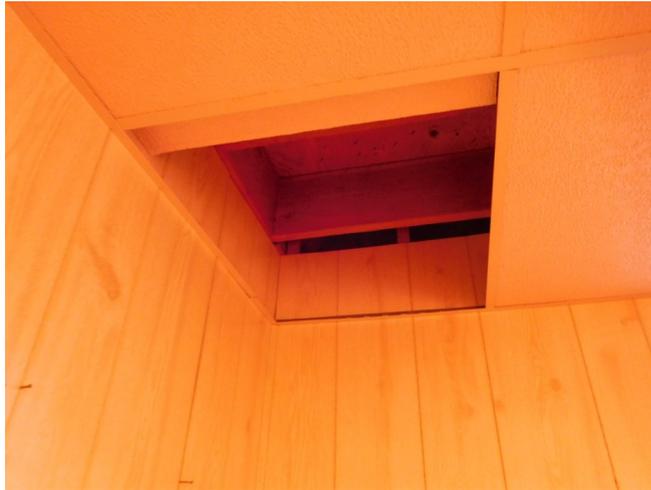
Only some of the suspended basement ceiling tiles were lifted to evaluate the area above the ceiling due to the damage that may occur to them when lifting them.

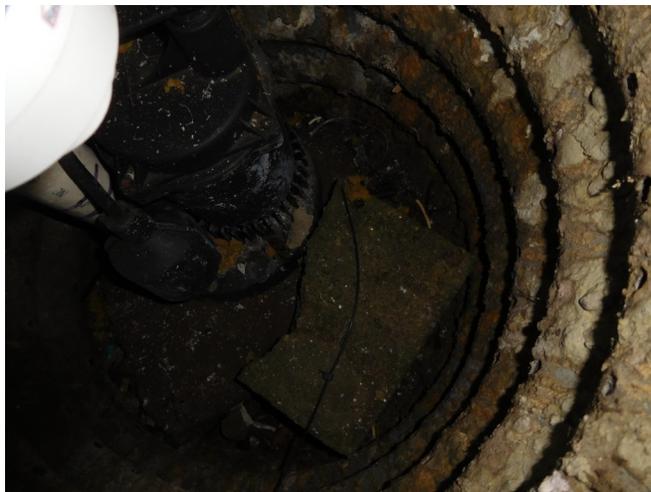
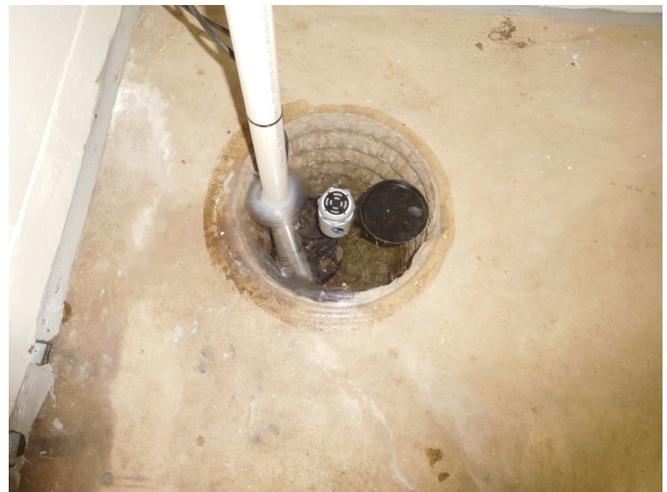
A sump, which is a pit in the slab, is located in the basement. An electric pump is provided in the sump to remove water that may accumulate below the home. It is recommended that a dedicated outlet for this unit be provided. The discharge piping terminates to the exterior away from the building. The pump was manual activated and functioned. Pumps are relatively inexpensive and easy to install. It is advisable to keep a spare pump in case of a failure to the existing one.

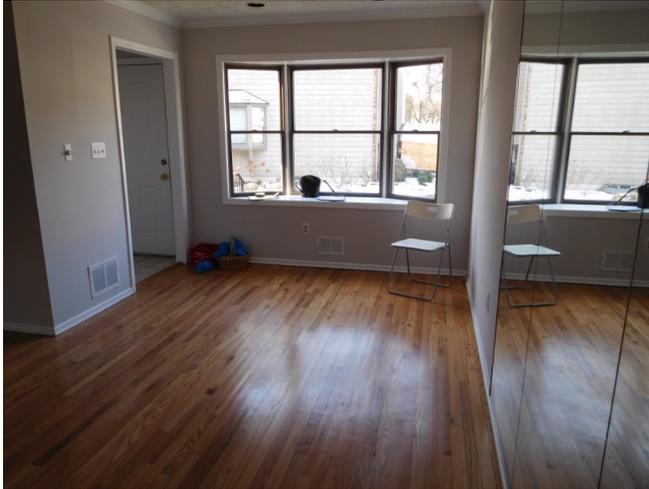
LIVING ROOM

The living room is in adequate condition. The walls and ceiling are adequately finished. The floor appears to be serviceable.

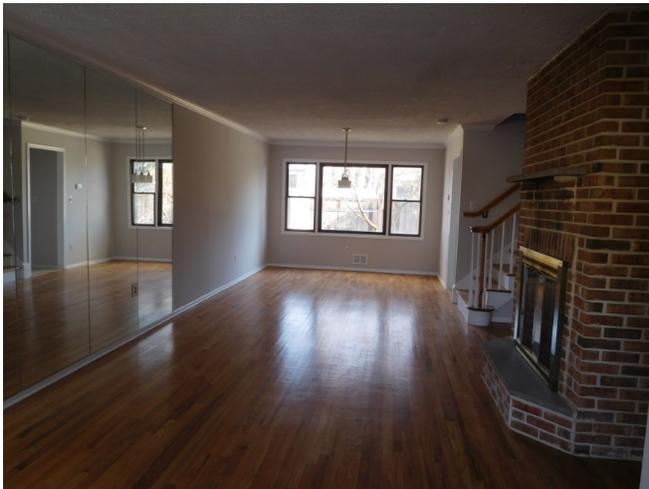
DINING ROOM

The dining room is adequate overall. The ceiling light and wall switch are functional. The walls and ceiling are adequately finished. The floor appears to be in adequate condition.

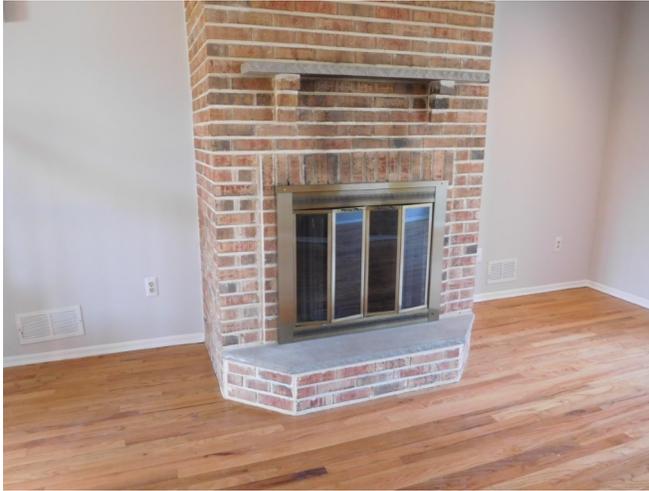
FIREPLACE

The gas fireplace was turned on and operated.

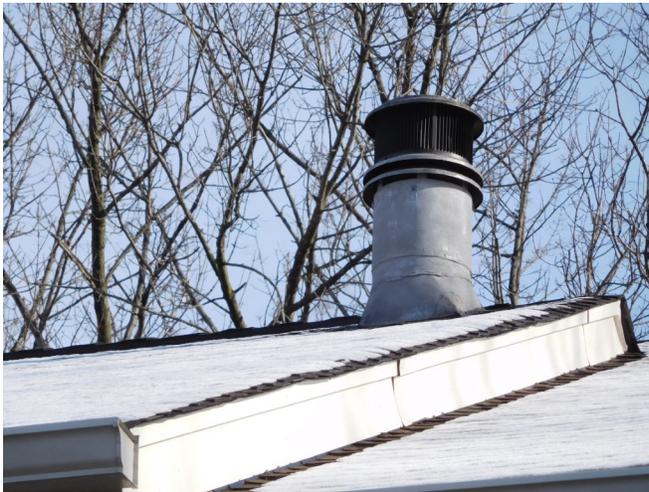
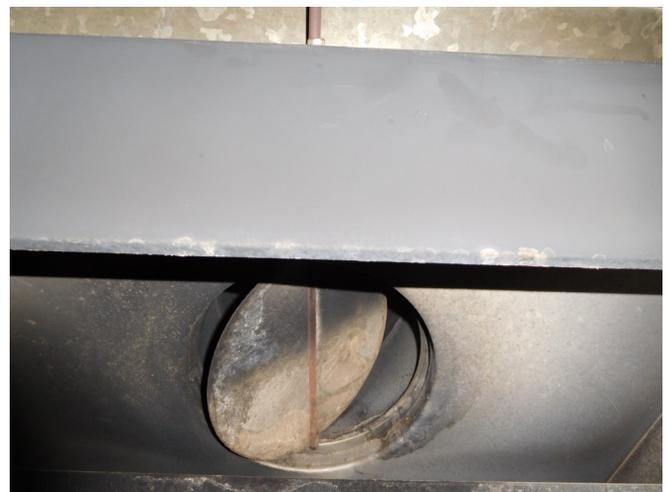
The damper for the fireplace is operable but needs to have a clamp installed on the damper to prevent the damper from staying closed when the fireplace is turned on which will cause dangerous carbon monoxide gases to enter the home.

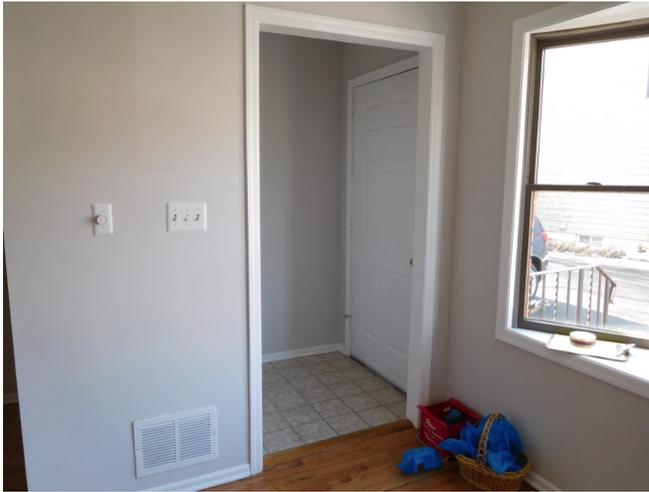
The front entrance area is in adequate condition.
The exterior and interior light fixtures are operable.

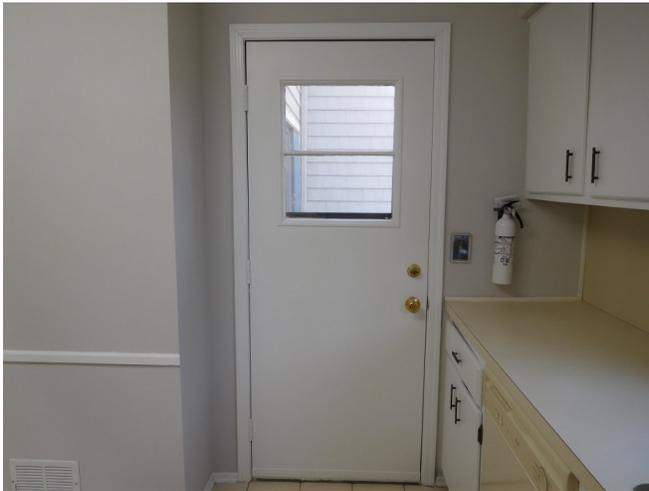
The rear entrance is also in adequate condition.
The exterior light is operable, and the door is in proper working order.

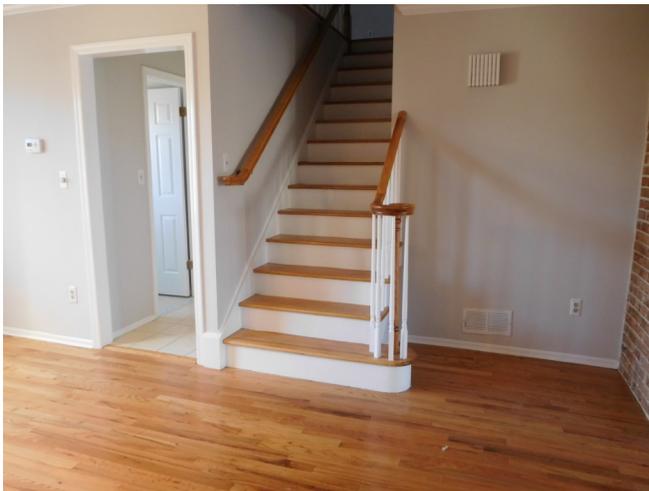
STAIRS

The stairs appear to be in sound condition and the banister appears to be adequately secured.

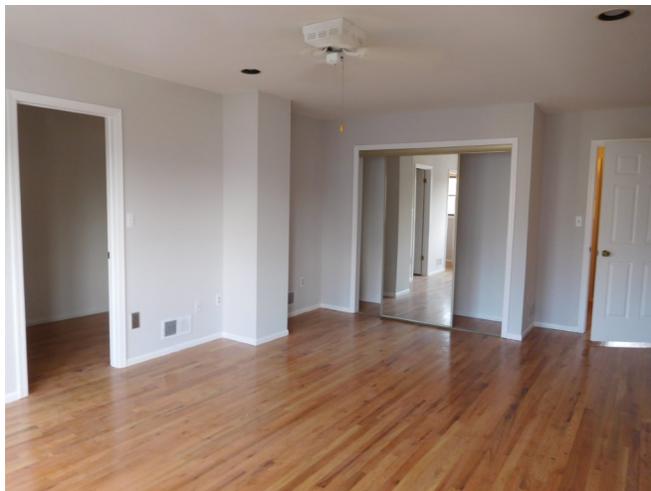
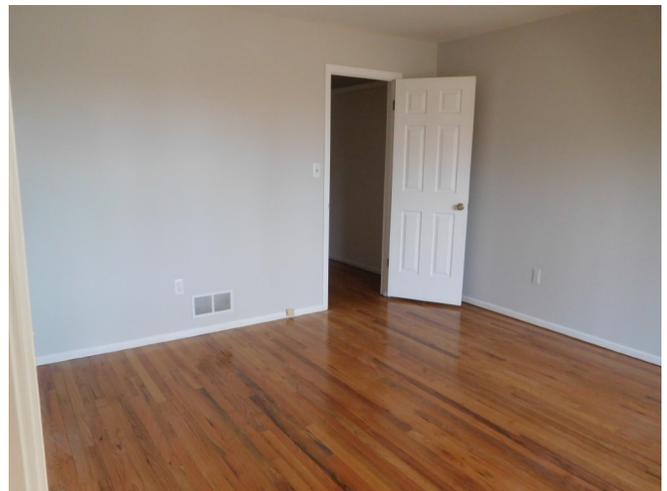
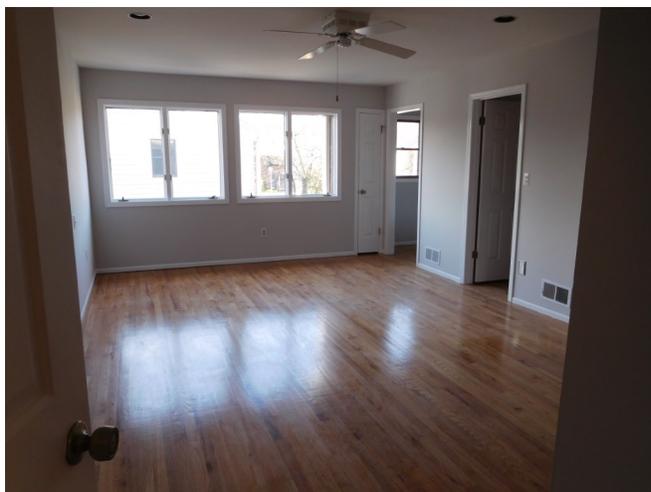
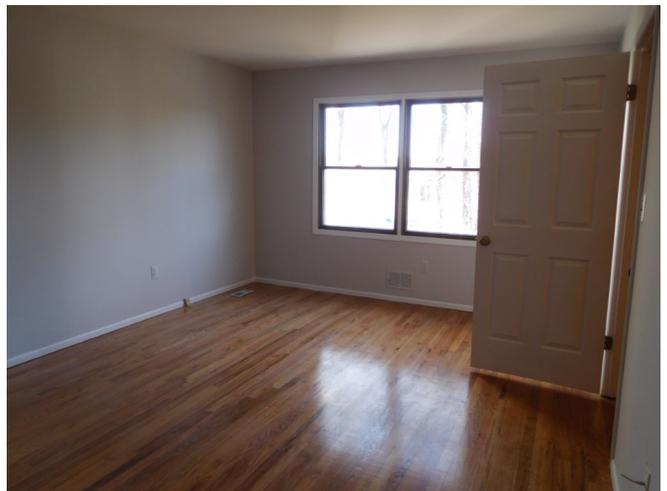
The bedrooms are believed to be in overall adequate condition. The walls and ceilings look to be in adequate condition. Entrance and closet doors are functional. Some may occasionally require planing or adjustment as a result of the normal movements which occur in a structure over time. The floors are in adequate condition.

No determination could be made as to what the bedroom wall switch operates because the ceiling fan works with the wall switch shut off.

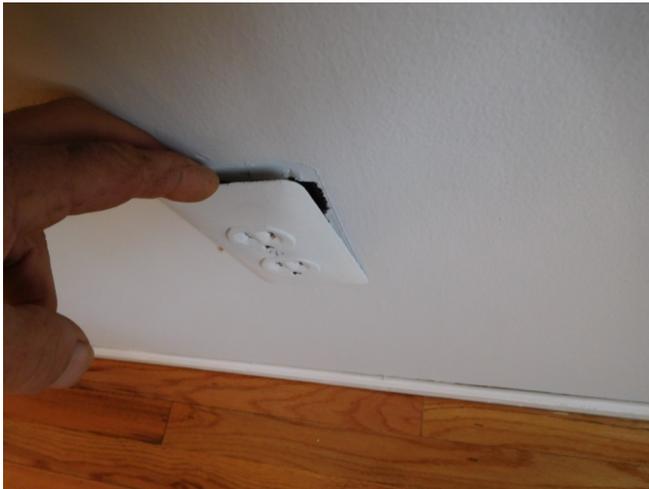
There is a loose electrical receptacle in the bedroom that needs to be secured in place.

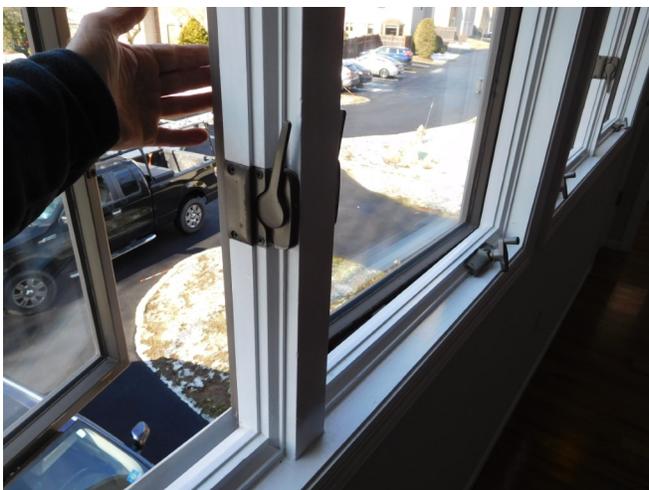
The crank for the 2nd to left bedroom window is stripped and needs replacement. The window can be opened but needs to be pushed closed from the exterior.

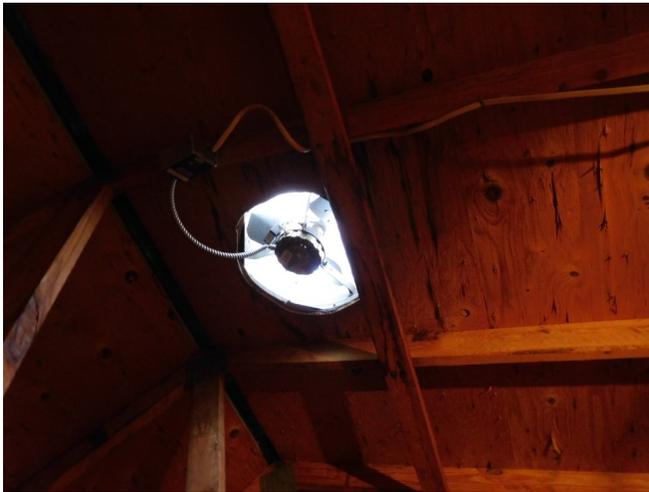
A thermostatically controlled roof fan is mounted in the attic to reduced heat build-up in this area.

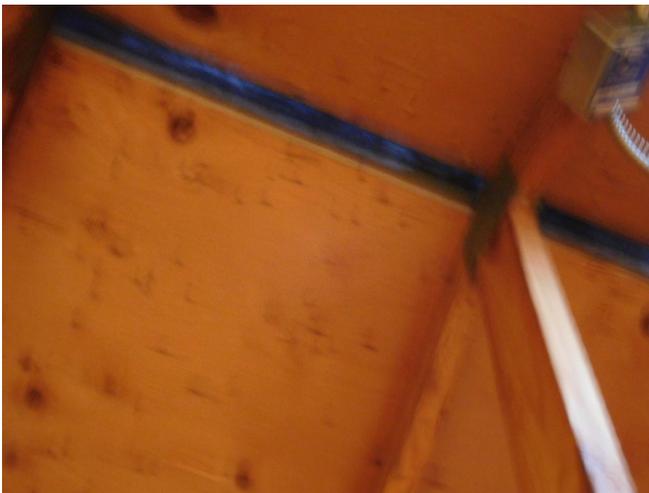
A continuous ridge vent is provided for ventilation to the attic.

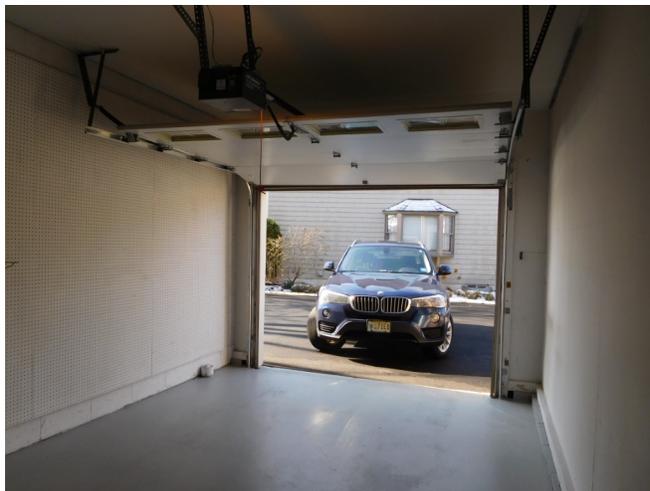
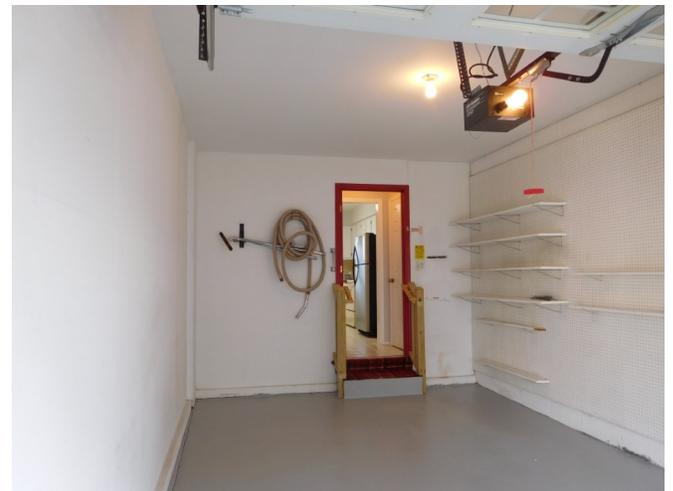
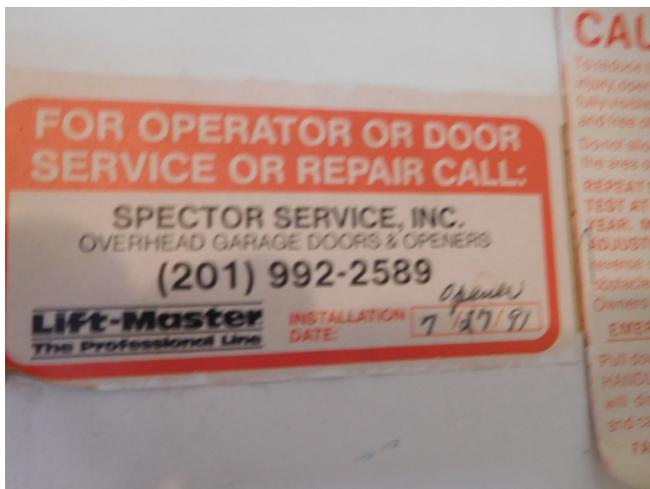
The automatic door opener was operated and appeared to function in an acceptable manner. A safety device is provided to stop the door from closing if an item is in the way, but this model does not have a floor beam sensor. An inventory of the transmitters was not conducted and should be obtained prior to closing if available.

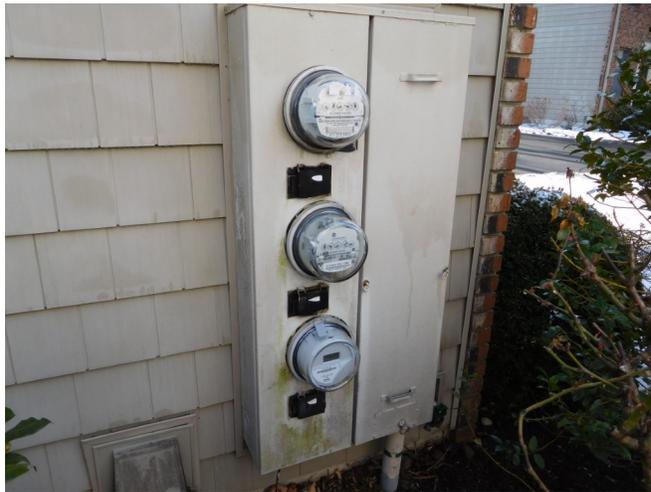
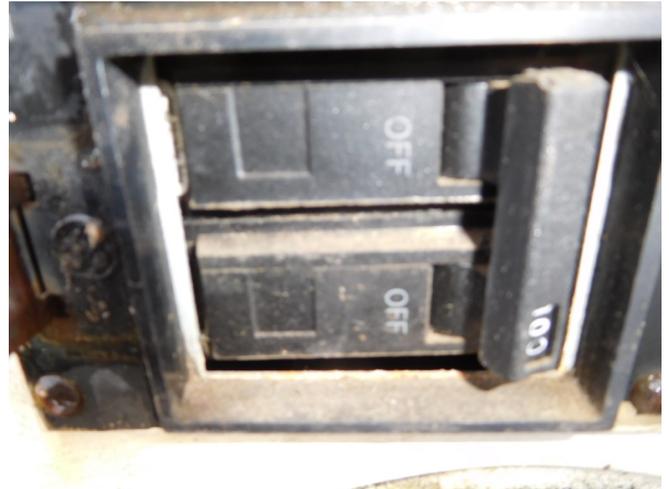
The main service disconnect switch has a capacity of 100 amperes, 240/120 volt electric service. The main ground appears to be adequately secure. Overcurrent protection is provided by circuit breakers located in a service panel in the basement.

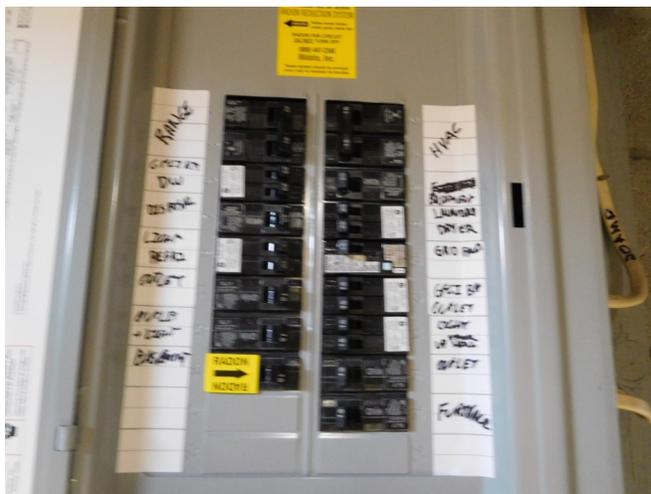
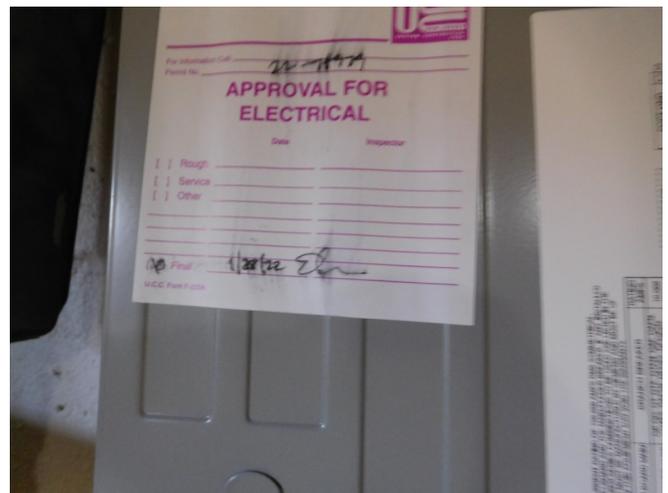
The panel was opened, and branch circuit wiring was found to be copper cable and appears to be in adequate condition. The main service line and major appliance feeds are often aluminum cable, which is an acceptable and standard practice.

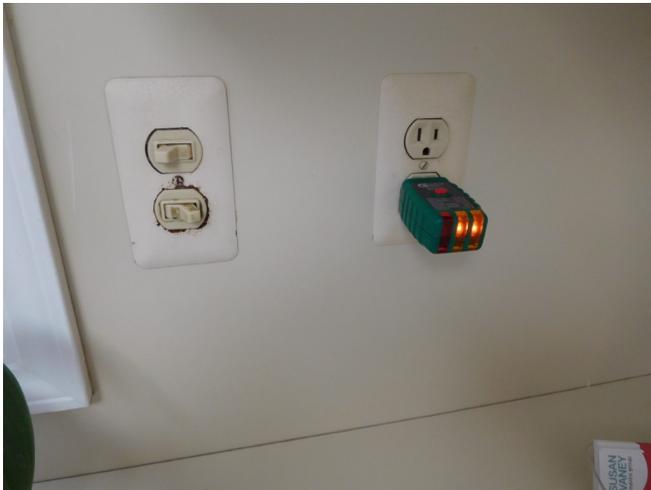
The kitchen outlets need to be GFCI protected and some other receptacles. Ground Fault Circuit Interrupter (GFCI) electrical outlets and breakers are a significant safety improvement and are required for bathrooms, kitchen countertop outlets, garages, unfinished basements, outside outlets, etc. to reduce potential electrical hazards in wet areas.

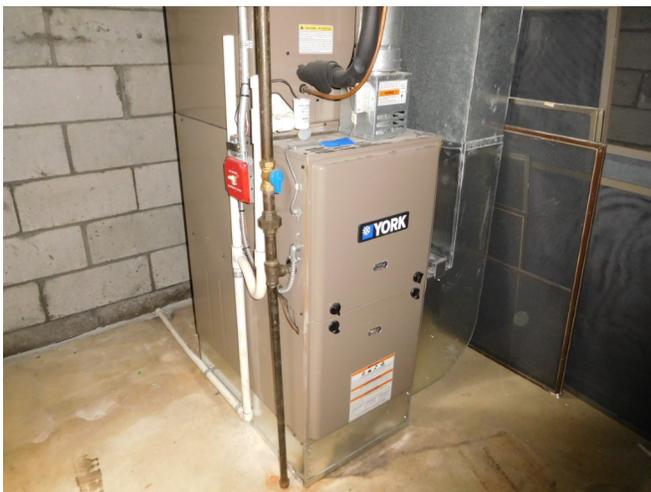
Heat is provided by a 2017 gas-fired, hot air furnace. A furnace of this type usually has an overall life expectancy of 20 to 25 years prior to the need for replacement.

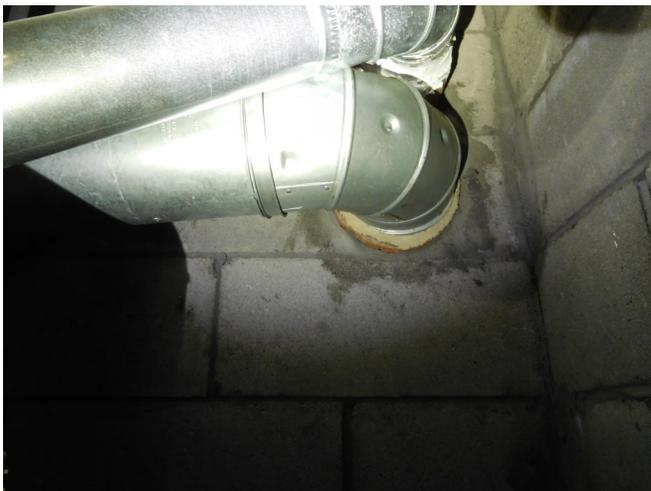
The flue piping is an adequate installation.

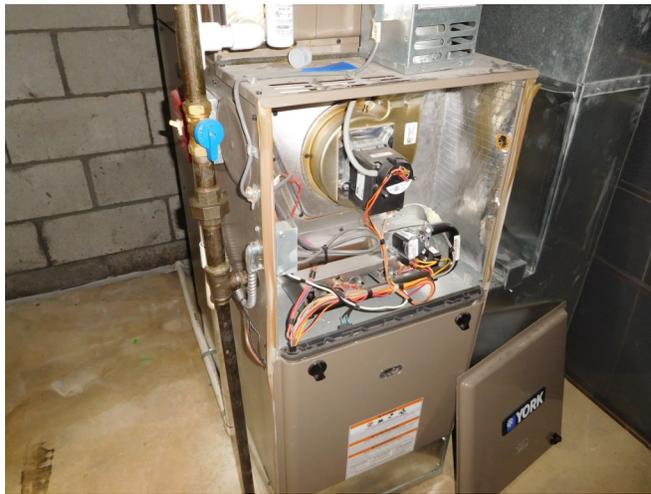
Internal access to the heat exchanger, which is the most critical component of the furnace, is very limited and this evaluation is based on external visual inspection only. The function of the heat exchanger is to separate the heated air to the rooms from the burning fuel. The burning fuel emissions can enter the air ducts if the exchanger is cracked or deteriorating. Automatic safety controls were not operated or evaluated, no components were disassembled, and only unsecured access panels were opened. If a more rigorous inspection is desired, you should contact your fuel supplier or a specialized heating/cooling contractor promptly. The utility company should be contacted to check

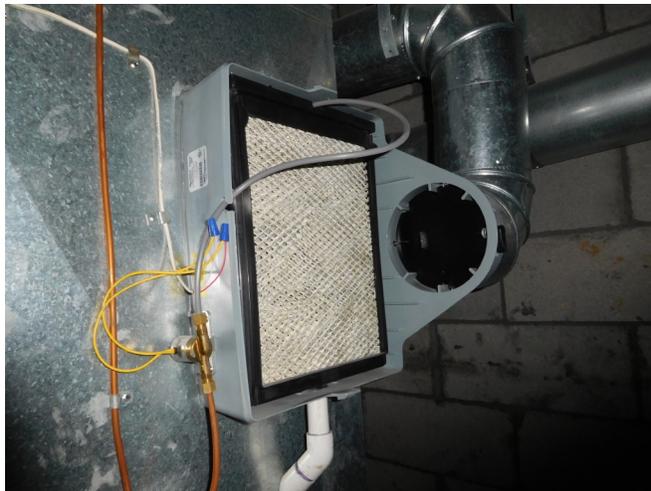
The humidifier equipment appears to be functioning properly. Humidifiers are high maintenance units which require cleaning and the regular replacement of some internal parts to remain serviceable. They are not critical to the operation of the furnace, but they do increase comfort. They need not be used unless desired. Maintenance is required every year for this equipment to function acceptably.

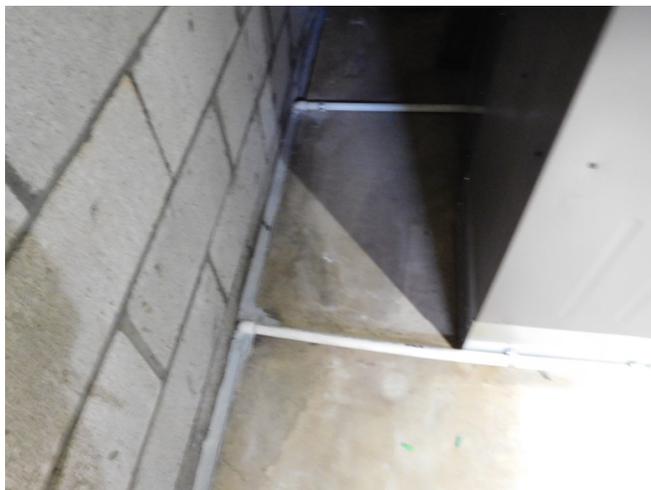
Condensate drains lines terminate in the French drains.

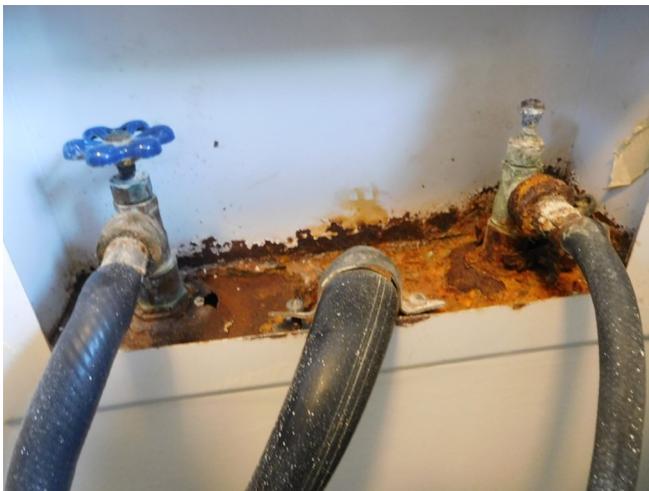
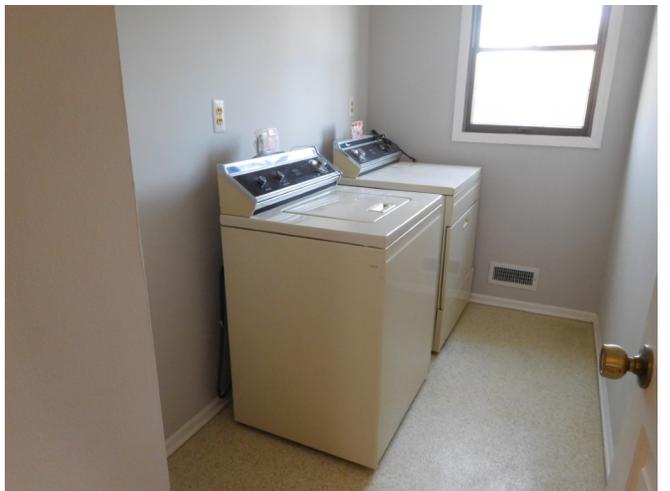
The hot and cold water hoses for the washing machines that have bubbles in the hoses that can burst and flood the home at any time needs to be replaced. The entire shut off box for the hose connections that is all rusted will need replacement. The main water for this unit was shut off as a precaution until the hoses are repaired.

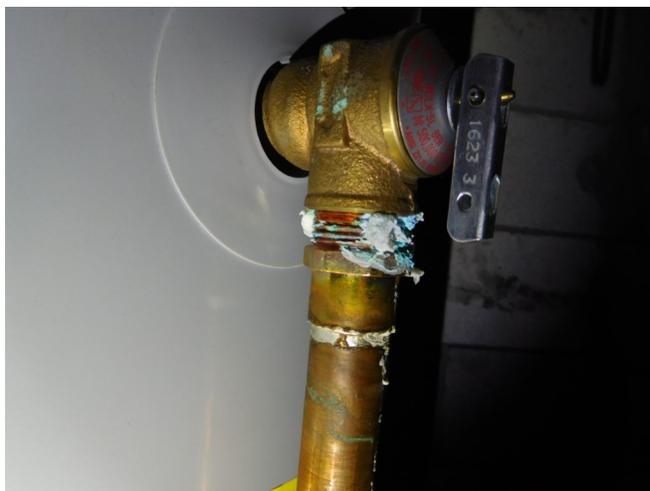
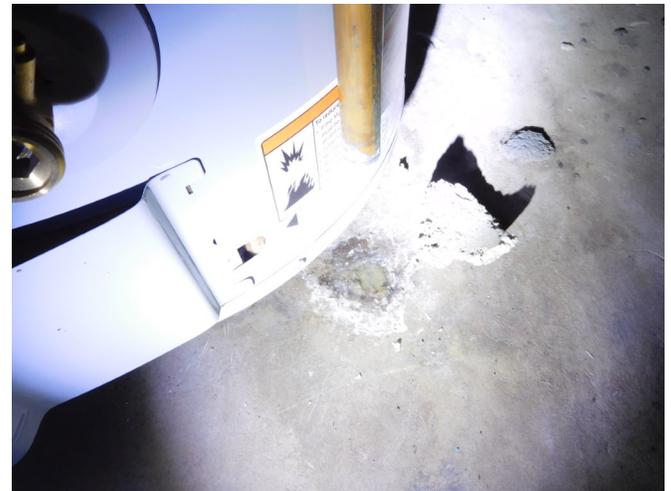
The relief valve on the water heater that is leaking needs replacement and an expansion tank needs to be installed to prevent the relief valve from leaking again.

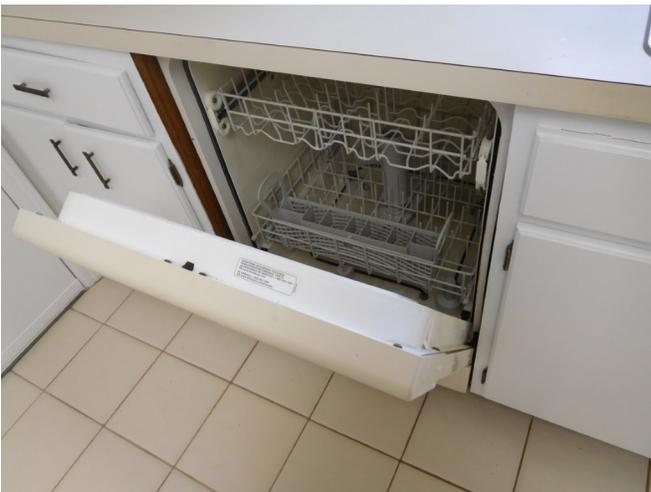
The dishwasher is old but was placed through a short cycle and functional without any leak noted.

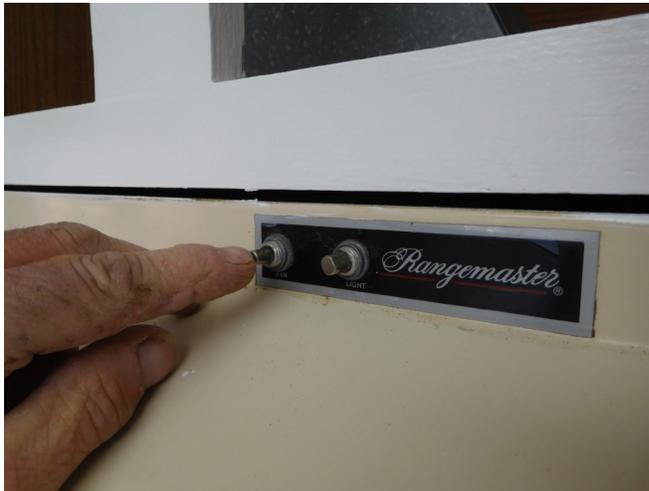
The exhaust fan above the stove does not always come on when you press the button to turn it on.

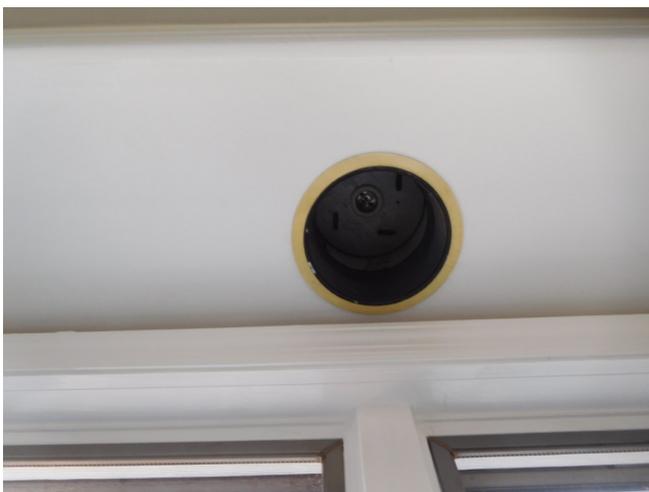
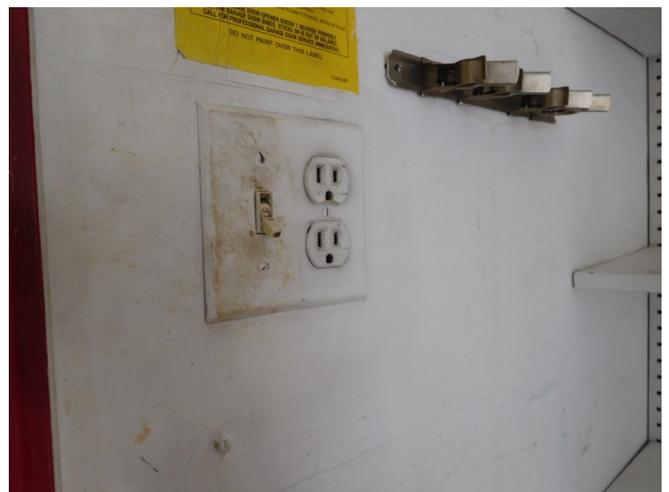
The overhead light above the kitchen sink did not function most likely the result of a missing bulb. The bulb needs to be replaced to confirm operation.

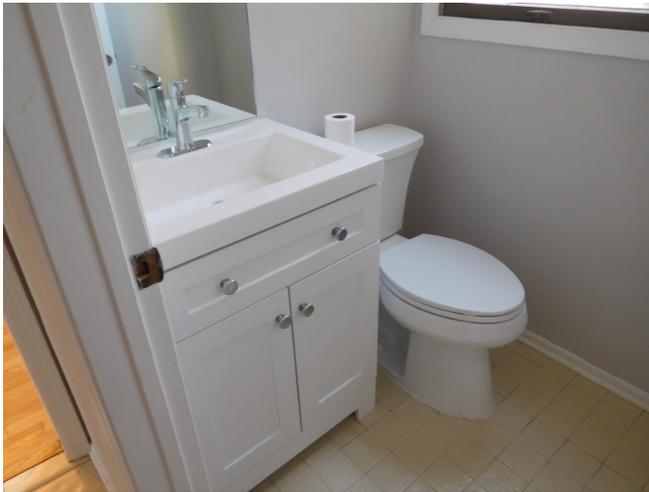
There is an active leak in the half bathroom drain line in the basement ceiling that needs repair. To properly repair this leak all the drain fitting will need to be removed that is not a simple job. It likes like someone tried to repair this leak with cement that did not stop the leak. It was stated that a leak from the 1st floor bathroom was repaired which may have been another leak not seen at the home inspection.

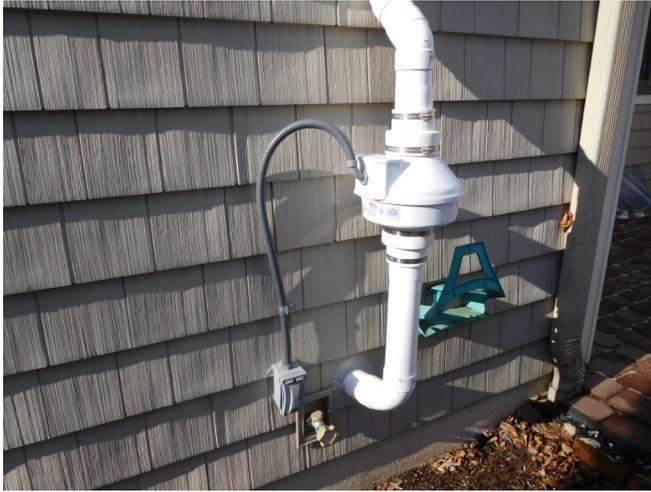
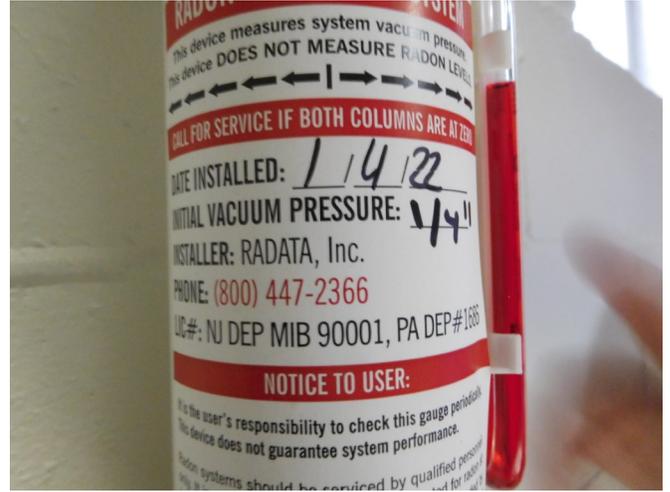
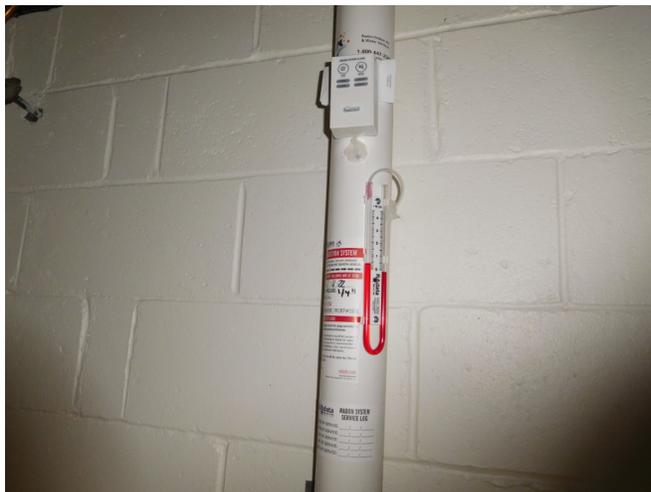
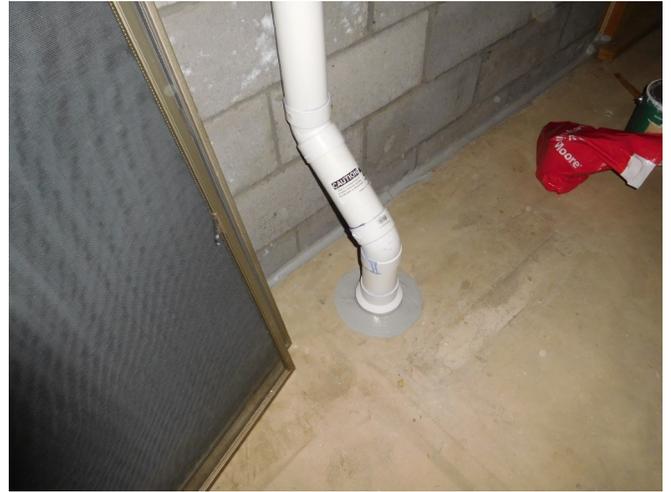
This home has a radon remediation system installed for the basement that is not checked as part of the home inspection, however a radon test is being conducted to determine the radon levels in this home with the system running.

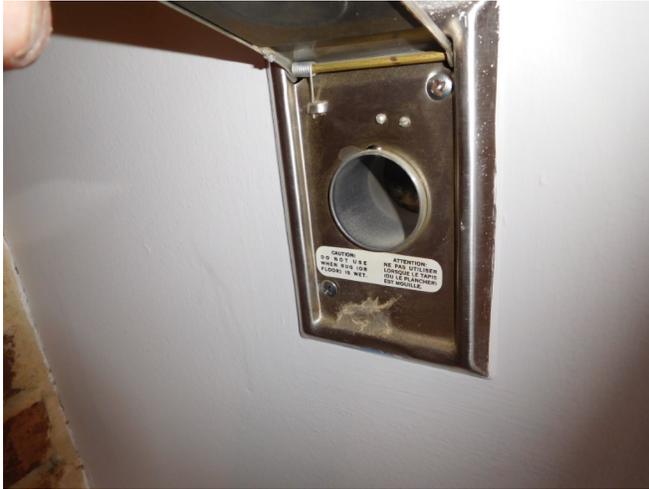
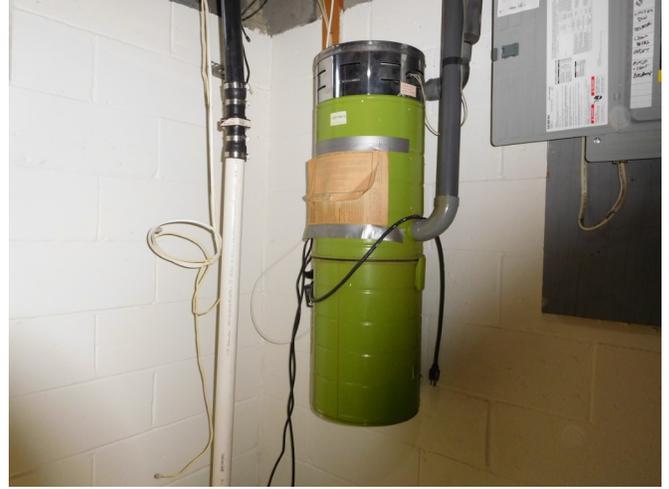
The central vacuum system that is old and not plugged in, did turn on when plugged in but may not have strong suction to be used.
